ROOT CAUSE EVALUATION NN 201843216

Steam Generator Tube Wear San Onofre Nuclear Generating Station, Unit 2

April 2, 2012

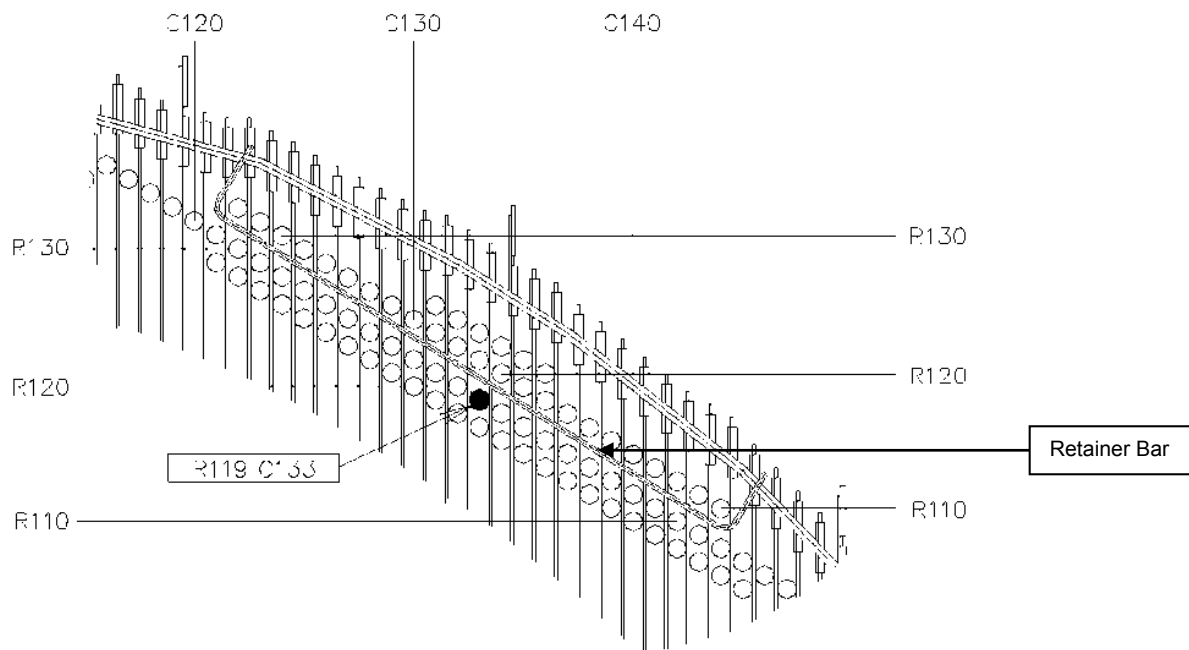
Figure 1 – Retainer Bar

There are [REDACTED] total retainer bars of two different diameter sizes in each steam generator. There are two groups of twelve bars. Each group has 6 large and 6 small diameter bars. The different sized bars were needed due to different size tube gaps in different areas. Only tubes adjacent to the smaller bar diameter experienced wear indications. The retainer bars capture two short rows of tubes, which physically stop AVB movement into or out of the bundle. Only those tubes immediately adjacent to both sides of the retainer bars (23 inside and 24 outside) are affected or potentially affected by vibration wear between the retainer bar and tubes. The first captured row is not affected by the retainer bar. (see Figure 1) The extent of tube to retainer bar wear was resolved by plugging and stabilizing tubes in accordance with the SG Program and Condition Monitoring and Operational Assessment (CMOA) report. There was similar wear, although to a lesser degree at the same location in Unit 3.

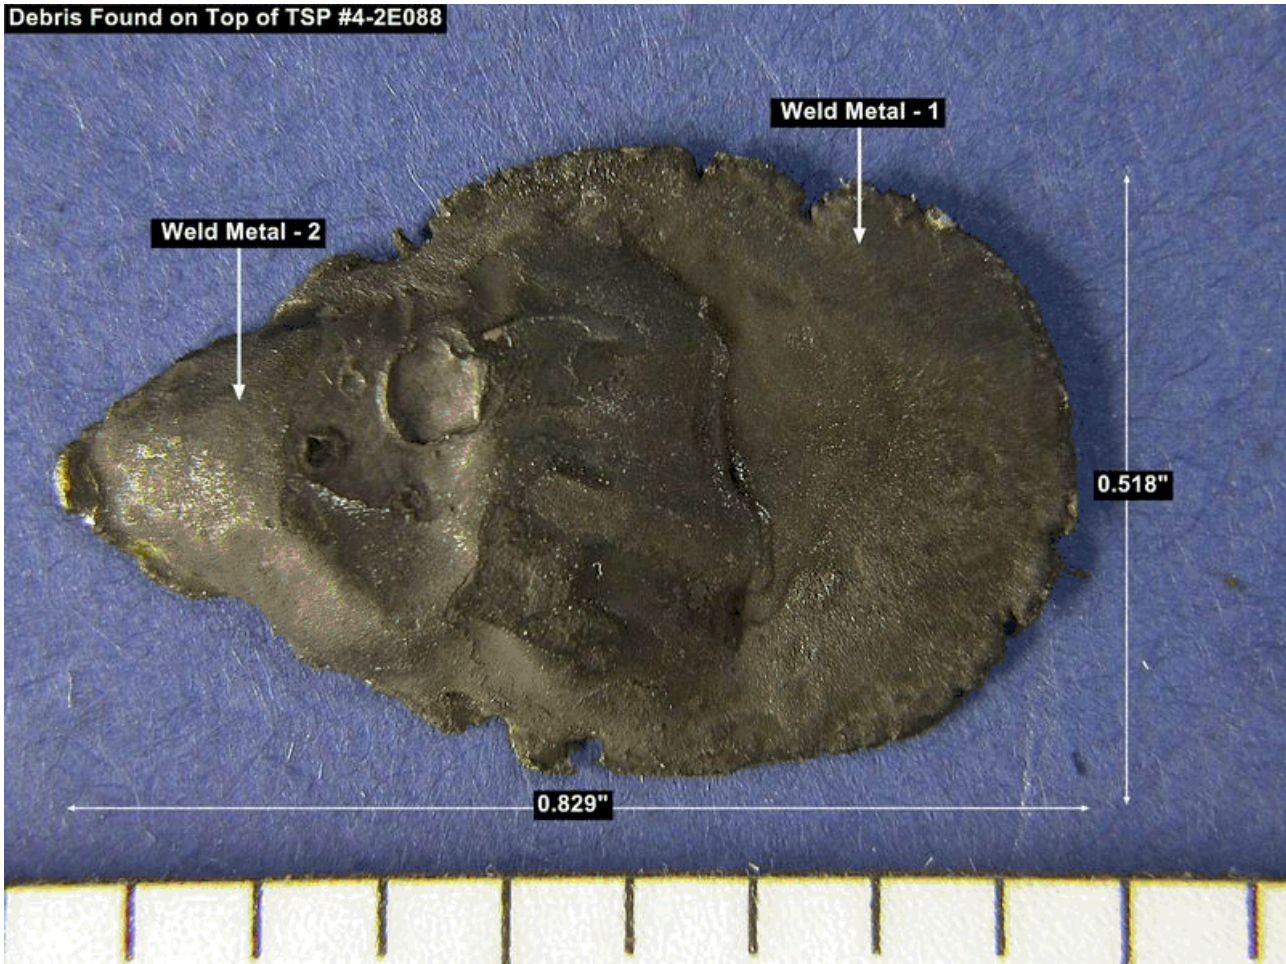
Debris Found on Top of TSP #4-2E088

ECT showed tube wear at a location other than an AVB, TSP, or free span tube to tube. The cause of the wear was determined to be a foreign object. The object was approximately 0.75 inches in diameter by 0.1 inches thick. [REDACTED]

The optical microscope examination revealed the debris as a weld metal of which a portion (identified in the photos as Weld Metal #1) had flowed into a crevice and a rounded portion (identified as Weld Metal #2). The nominal thickness of the Weld Metal #1 was measured as 0.016" and it tapers down at the extremities.
