Citizens' Oversight Projects (COPs)

August 24, 2012

**QUESTIONS FROM CITIZENS OVERSIGHT PROJECTS
(COPS) REGARDING STEAM GENERATOR TUBE
FAILURES AT SAN ONOFRE NUCLEAR GENERATING
STATION**

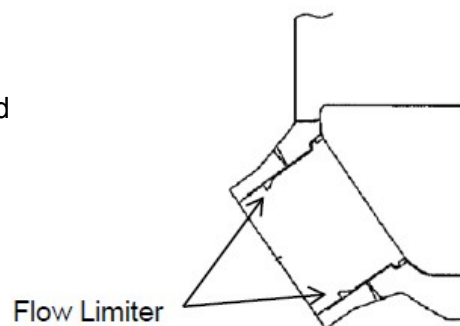
Flow Limiter for Primary Inlet Nozzles – The replacement steam generators were designed with a flow limiter located in the primary inlet nozzle (see figure below) in order to make the reactor coolant system flow similar to the flow rate of the original steam generator and not exceed the maximum allowable reactor coolant system flow rate. The licensee's evaluation for the engineering design package determined

that although the original steam generators had a number of plugged tubes, the reactor coolant system flow rate of the original steam generators was near the design requirement. Because the replacement steam generators has 377 more tubes than the original steam generators, and contained tubes with u-bends versus “square bends”, the pressure drop of the replacement steam generators with no plugged tubes would be much less than the original steam generators resulting in a higher flowrate.

The flow limiter was designed to ensure the total “best estimate” reactor coolant flow rate with the replacement steam generators installed would not exceed 106.5 percent of the design volumetric flow rate of 396,000 gallons per minute at a reactor coolant system cold leg temperature of $T_{cold} = 540.9^{\circ}F$. For Unit 2 replacement steam generators, the flow limiter diameter to nozzle inner diameter ratio was 0.94 while the ratio for Unit 3 steam generators was 0.915 due to Unit 3 reactor coolant pump replacement. The flow limiter dimensions resulted from a scaled model test performed by Mitsubishi and it was designed to be machined as part of the nozzle base metal.
