FAR OUTSIDE THE NORM:  
The San Onofre Nuclear Plant's  
Steam Generator Problems  
in the  
Context of the National Experience with  
Replacement Steam Generators

by  
Daniel Hirsch  
and  
Dorah Shuey

September 12, 2012

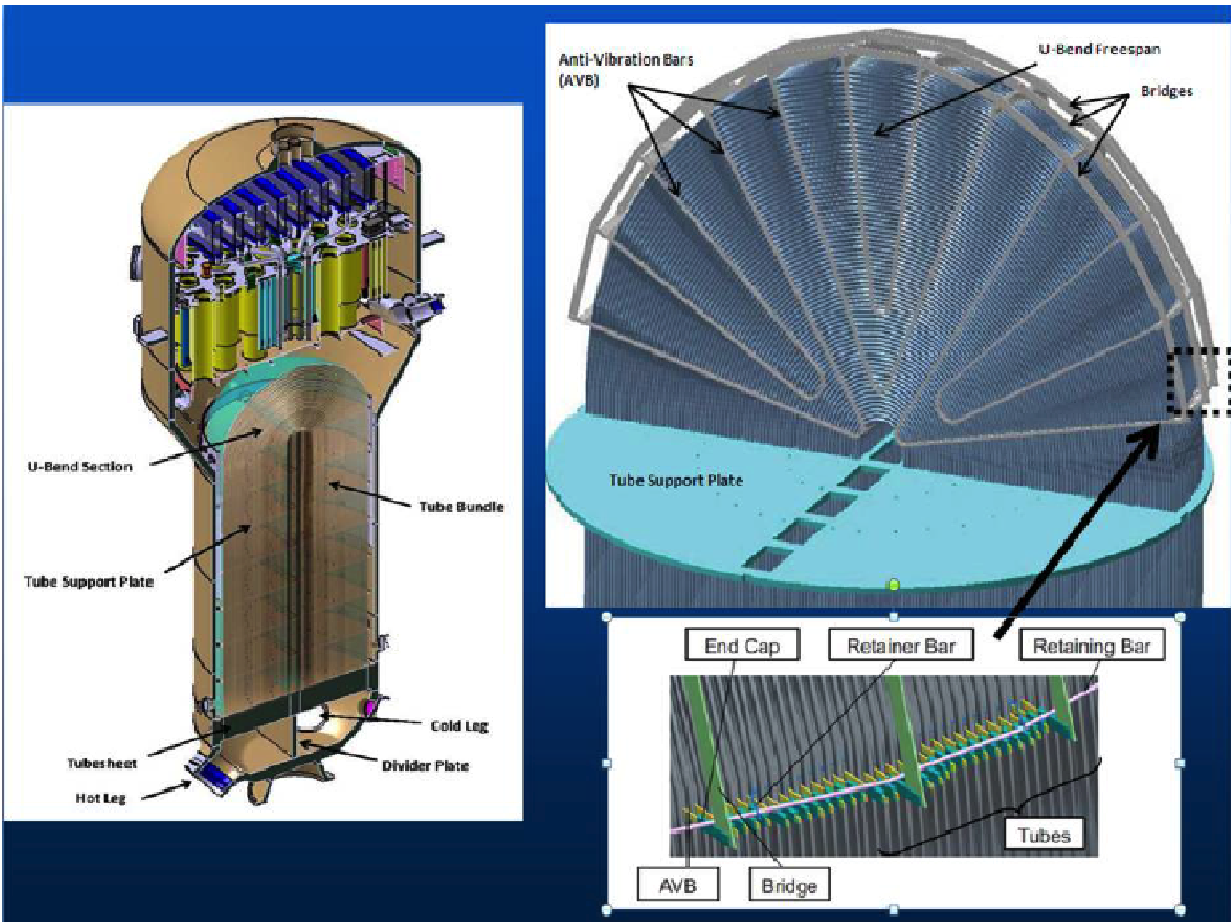
Figure 1 San Onofre Replacement Steam Generator Schematic

The tubes are in an inverted U shape: in the upper part of the steam generator, the tubes bend to return downward again. There are four key parts of the steam generators for the present discussion: the tube support plates, through which the tubes run; the anti-vibration bars (AVBs), designed to reduce vibration; the retainer bars, which help retain the AVBs; and the U-Bend Freespan, where the tubes bend near the top of the steam generator and have no immediate support.

There thus are at least four locations where steam generator tubes can get damaged: they can rub against the tube support plates, the AVBs, the retainer bars, or against each other in the U-Bend Freespan.<sup>iv</sup> Damage has occurred in the new steam generators at San Onofre at all four locations.

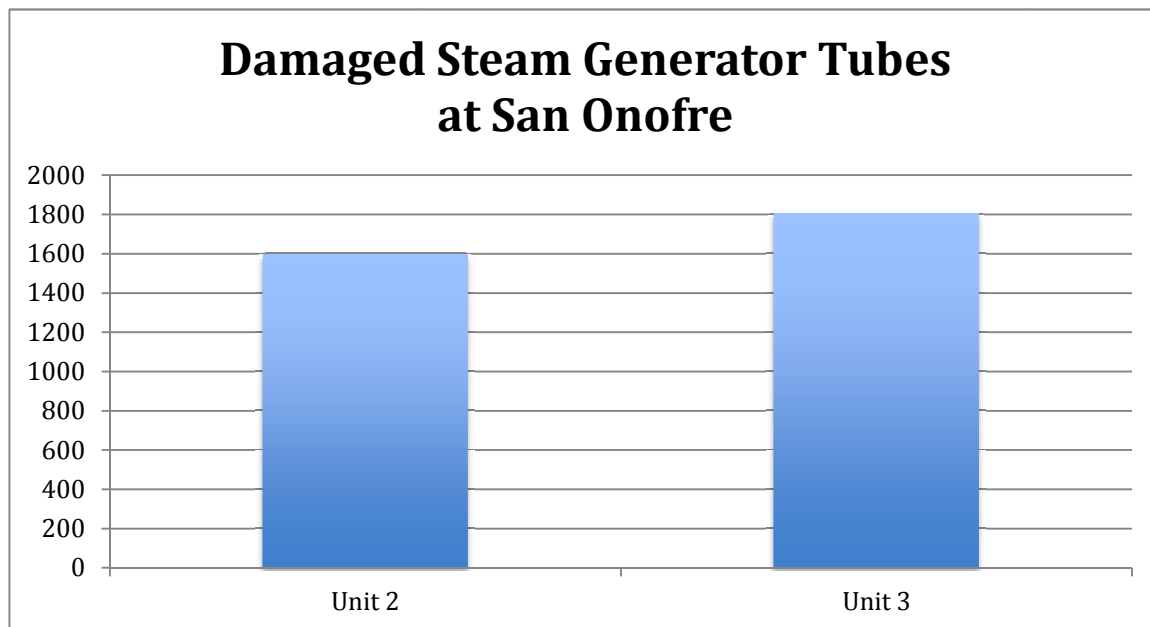
Figure 2

The data tables posted by NRC show similar numbers of damaged tubes in the two units. Unit 2 has 1,595 tubes with wear, Unit 3 has 1,806.

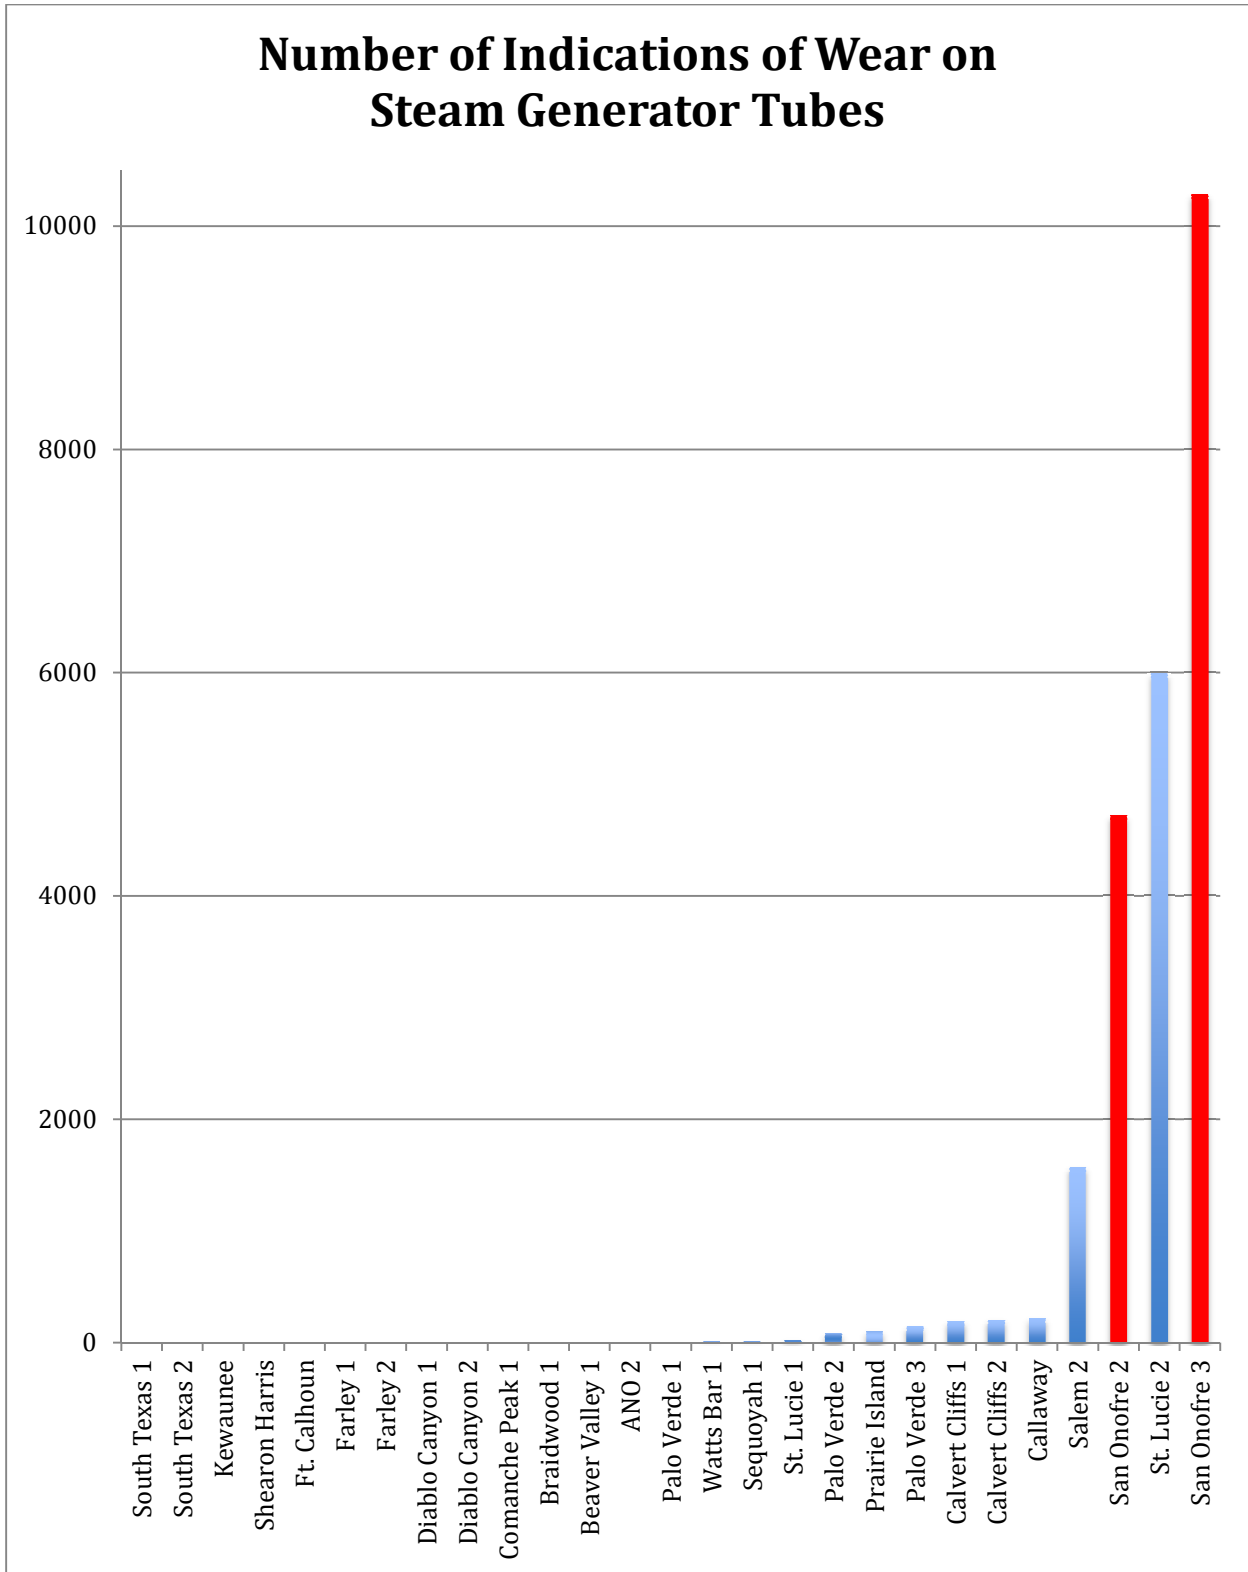
Figure 3

As dramatically shown in Figures 3, 4, and 5 of this report, the San Onofre experience after only two or less years of operation with replacement steam generators lies far outside the bounds of normality when compared to the experience of other nuclear units with such replaced components. Steam generators, and more specifically the tube boundaries, play a critical role in assuring plant safety and the containment of possible radioactive releases. In spite of Edison's attempt to assert a different level of risk between Units 2 and 3, it seems clear that similar design and failure challenges are present in both units and that future operation of either unit has not been technically justified. It is my opinion that measures necessary for the future safe operation of either of these unit have not been adequately put forth at this time, and that operation with or without reduced power of Unit 2 should not be authorized.

- **The median number of steam generator tubes showing wear after one cycle of operation nationally is—FOUR. San Onofre Unit 2 had 1595 damaged tubes, approximately 400 times the median; San Onofre Unit 3 had 1806.**
- **The median number of wear indications on steam generator tubes after one cycle of operation is—FOUR. San Onofre Unit 2 had 4721, greater than a thousand times more. San Onofre Unit 3 had 10,284.**
- **The median number of steam generator tubes that were plugged after one cycle of operation is—ZERO. San Onofre Unit 2 had 510; Unit 3 had 807.<sup>xxi</sup>**

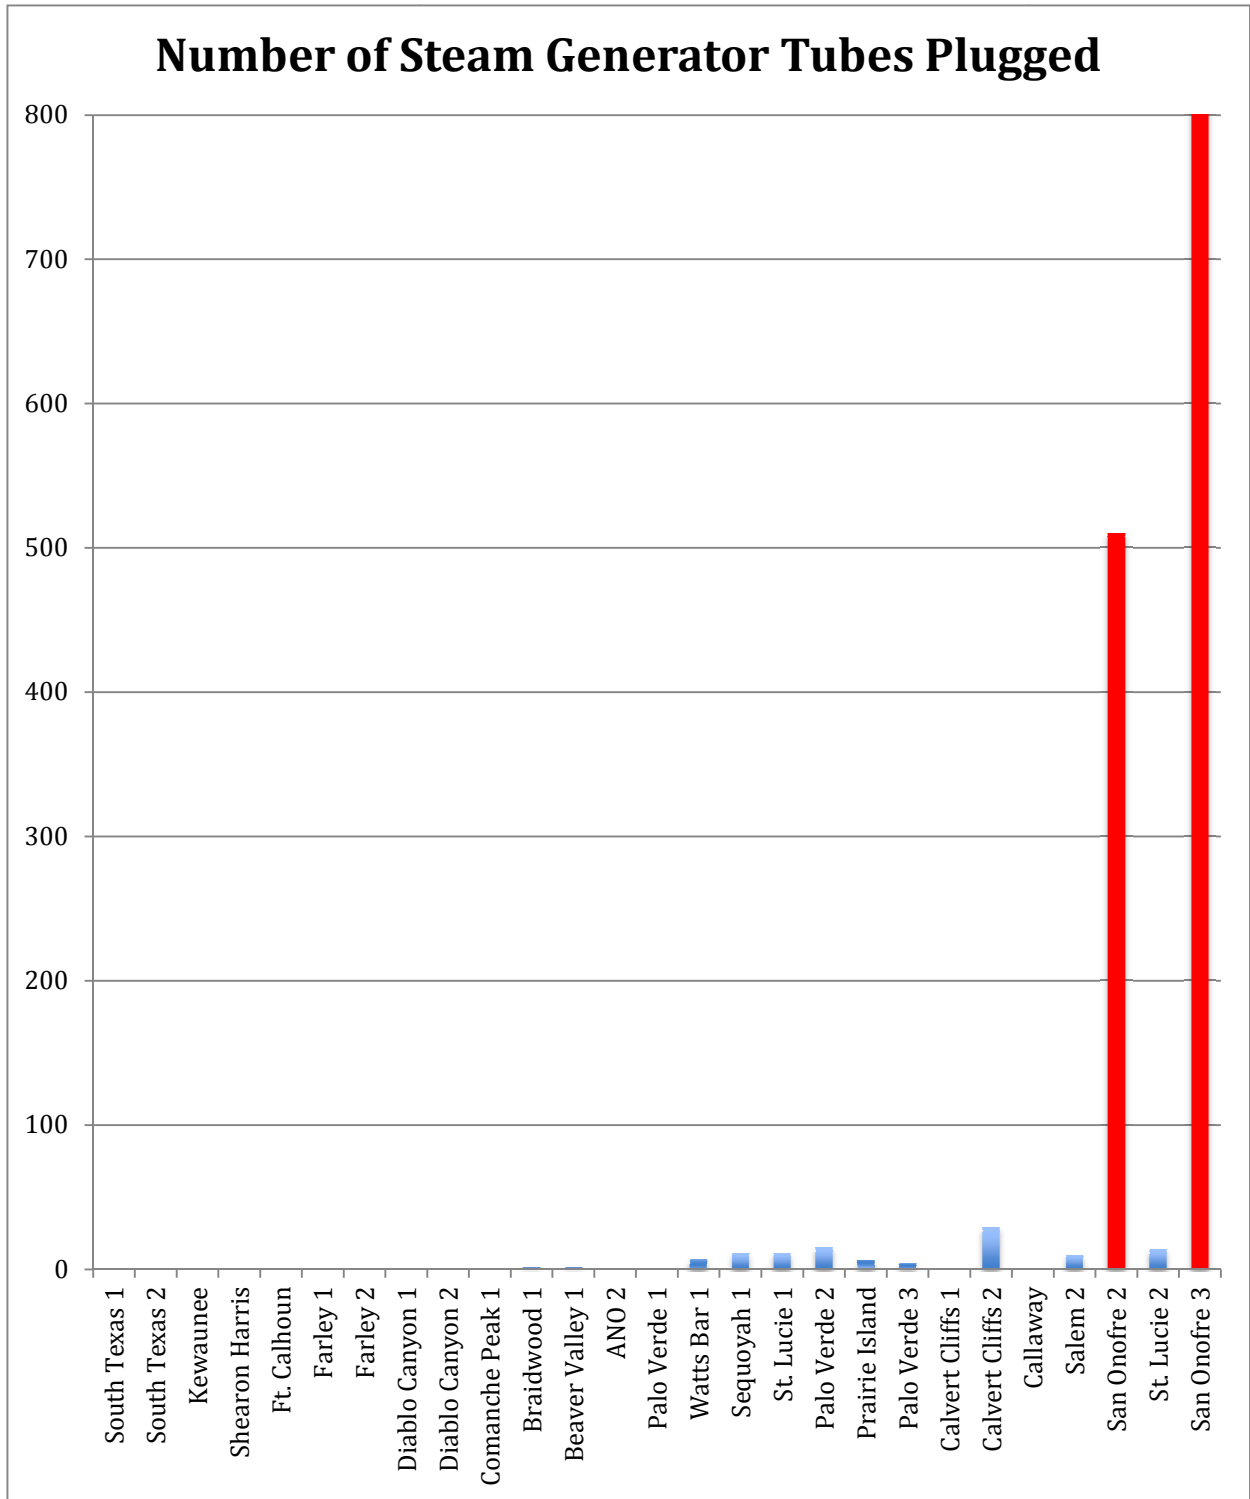
Figure 5

Additionally, as will be seen in Table 3 and Figure 5, the number of steam generator tubes that have had to be plugged in each reactor is in the same approximate range: 510 in Unit 2 and 807 in Unit 3. As this report shows, these numbers are dramatically higher than the national experience. Each San Onofre unit has had to plug many times more tubes than all reactors with new steam generators in the country, over a comparable operational period, combined.
