BEFORE THE PUBLIC UTILITIES COMMISSION OF THE STATE OF CALIFORNIA

**ORDER INSTITUTING INVESTIGATION REGARDING
SAN ONOFRE NUCLEAR GENERATING STATION
UNITS 2 AND 3**

Attachment A: July 18, 2012 San Onofre Nuclear Generating Station – NRC
Augmented Inspection Team Report

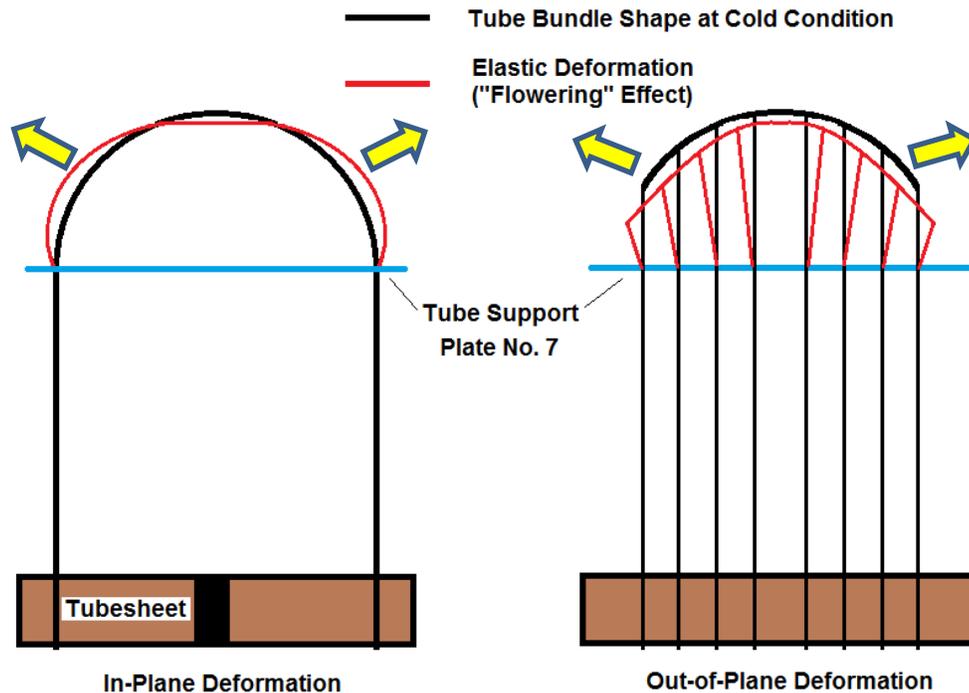
The failure mechanism model also considered a fluid dynamic effect associated with the spreading of the tubes in the U-bend region during normal operating conditions. This effect was informally referred to as "flowering," due to the characteristic shape in which the tube bundle spreads transverse to the plane of the u-bends at normal operating conditions. "Flowering" was described as the elastic deformation of the anti-vibration bar structure and the tube bundle in the U-bend region, as a result of thermal expansion and fluid dynamic pressure acting on the secondary side of the tubes (see figure below). The deformation caused by the "flowering" effect was believed to result in multiple areas of no contact between the anti-vibration bars and the tubes, which minimized resistance to in-plane motion of the u-bend area of the tubes.

Description of "Flowering" Effect (Conceptual Drawing – For Illustration Purposes Only)

Mitsubishi considered that the collective contribution of the factors described above resulted in conditions in the U-bend that were highly susceptible to excessive tube vibration. The in-plane vibration of the tubes in the U-bend region allowed direct contact between free-span sections of the tubes, resulting in the unanticipated tube-to-tube wear.

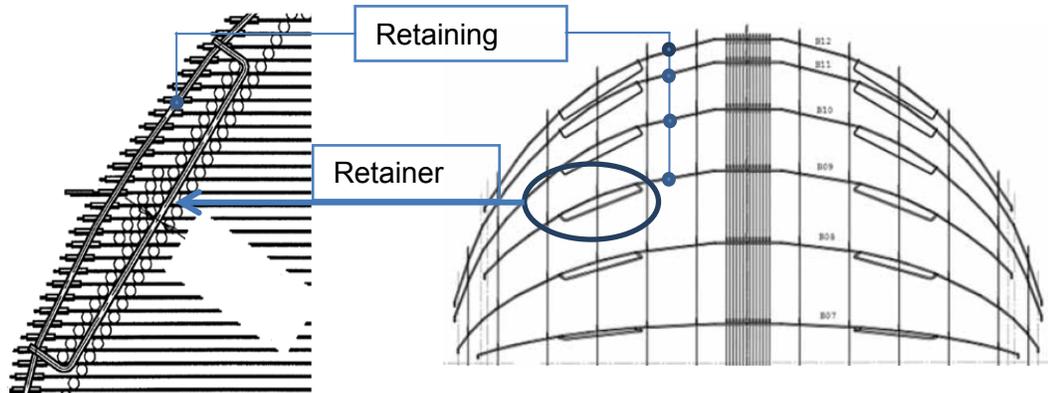
Description: In February 2012, the licensee identified wear indications in Unit 2 replacement steam generators at the tube locations in contact with the retainer bars (see figure below). Some of the indications showed excessive wear with a maximum degradation of 90 percent through wall.

Retainer Bar Design and Location of Affected Tubes (For Illustration Purposes Only)

The team identified that the design of the replacement steam generators did not expect any potential vibration concerns in the area of the tube bundle where the retainer bars were located. The basis for Mitsubishi's design philosophy relied on the following factors:

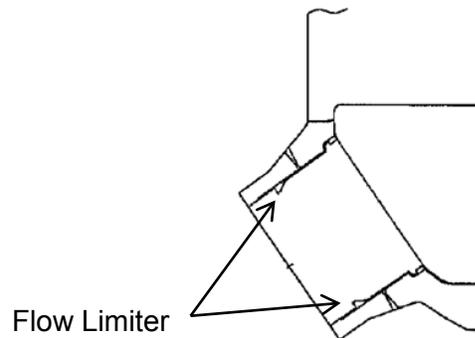
- Flow Limiter for Primary Inlet Nozzles** – The replacement steam generators were designed with a flow limiter located in the primary inlet nozzle (see figure below) in order to make the reactor coolant system flow similar to the flow rate of the

Replacement Steam Generator Primary Inlet Nozzle (For Illustration Purposes Only)

The flow limiter was designed to ensure the total "best estimate" reactor coolant flow rate with the replacement steam generators installed would not exceed 106.5 percent of the design volumetric flow rate of 396,000 gallons per minute at a reactor coolant system cold leg temperature of $T_{cold} = 540.9^{\circ}\text{F}$. For Unit 2 replacement steam generators, the flow limiter diameter to nozzle inner diameter ratio was 0.94 while the ratio for Unit 3 steam generators was 0.915 due to Unit 3 reactor coolant pump replacement. The flow limiter dimensions resulted from a scaled model test performed by Mitsubishi and it was designed to be machined as part of the nozzle base metal.

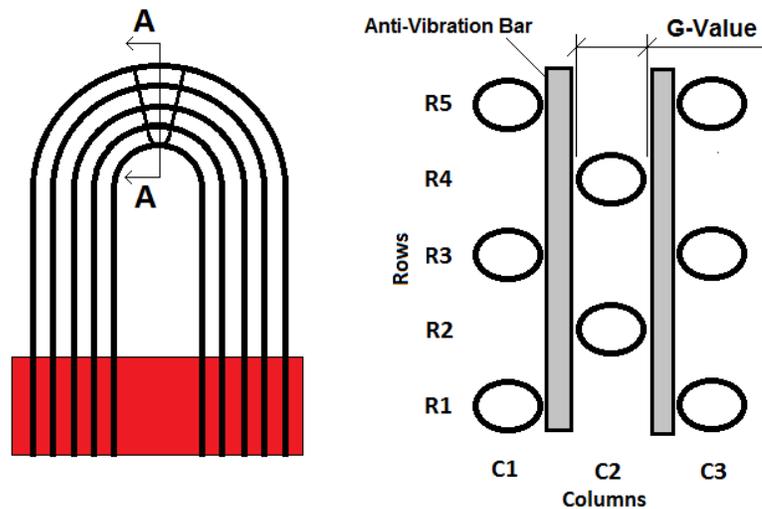
Section A-A

The first dimensional control under consideration was the improvement of tube roundness in the section of the tubes that was bent to form the U-bend shape. During fabrication of Unit 2 steam generator 2E0-89, the supplier of tubular product for Mitsubishi (i.e. Sumitomo), experienced quality issues to meet the G-values established in the design specifications, resulting in a high number of tube rejections. The G-value was a measure of departure from roundness, or "ovality," after the tubes were bent and it was controlled in order to control the gap between tubes and anti-vibration bars (see figure below). The G-values were measured at different locations along the U-bend section of the tubes for a selected number of tubes per row, as established in Mitsubishi's procedure. The acceptance criteria for G-value varied depending on the row where the tubes were installed. The acceptance criteria also remained the same throughout the fabrication of Unit 2 and Unit 3 replacement steam generators.

Description of G-Value Parameter (Conceptual Drawing – For Illustration Purposes Only)

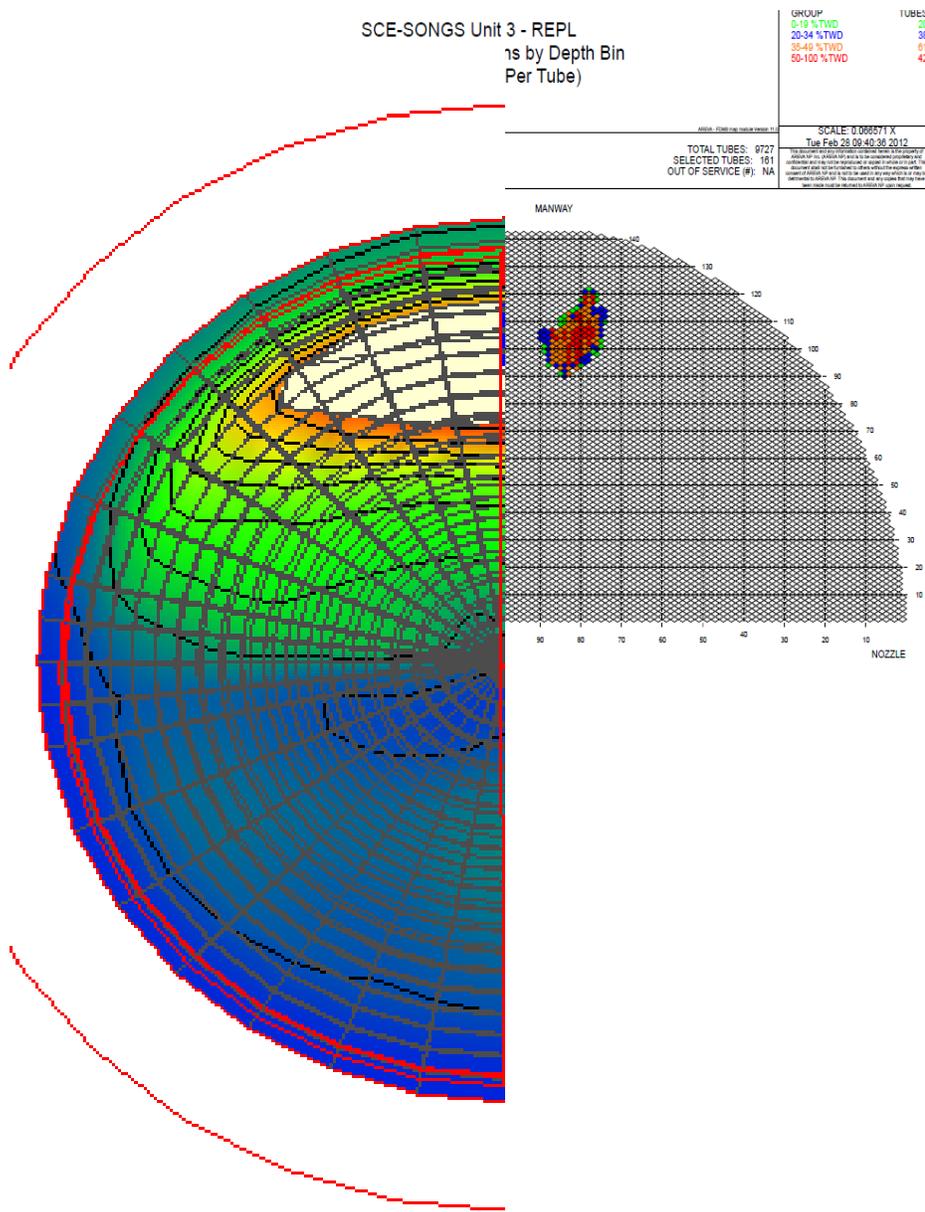
Figure 5

The ATHOS code predicted regions of high void fraction and high steam velocities are superimposed with tube-to-tube wear indications from Unit 3 steam generator 3E0-88

The NRC analysis indicated a correlation with the tube-to-tube wear based on a combination of high void fraction and high steam velocities. It should be noted that the traditional forcing function, fluid velocity squared times density, does not show good agreement with the tube-to-tube wear patterns. This indicated that the high quality steam fluid velocities and high void fraction may be sufficiently high to cause conditions in the generators conducive for onset of fluid-elastic instability.

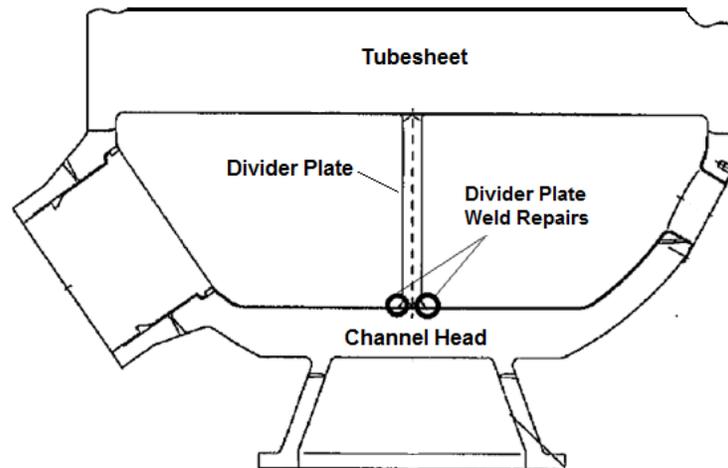
On March 18, 2009, Mitsubishi identified cracking indications in the weld between the divider plate and the channel head of Unit 3 replacement steam generator 3E0-88 (see figure below), after completion of the ASME Section III hydrostatic test on the secondary side. The extent of condition investigation also identified similar cracking indications in Unit 3 replacement steam generator 3E0-89. As discussed in Section 4 of this report, the cause of the cracking was attributed to the air carbon-arc gouging process used to remove the clad weld from the channel head. The team reviewed information associated with the repair of the cracking indications to assess whether the repair activities resulted in relevant differences in design and fabrication that could be considered as contributing factors for the cause of the tube-to-tube wear issue in Unit 3.

Location of Divider Plate Weld Repairs in Unit 3 Steam Generators (For Illustration Purposes Only)
