# **Dry Storage Issue at San Onofre**

**David Lochbaum**

**August 2018**

**During the August 9, 2018, Community Engagement Panel meeting, a worker revealed that a spent fuel canister could have been dropped on August 3<sup>rd</sup> due to poor performance by two workers.**

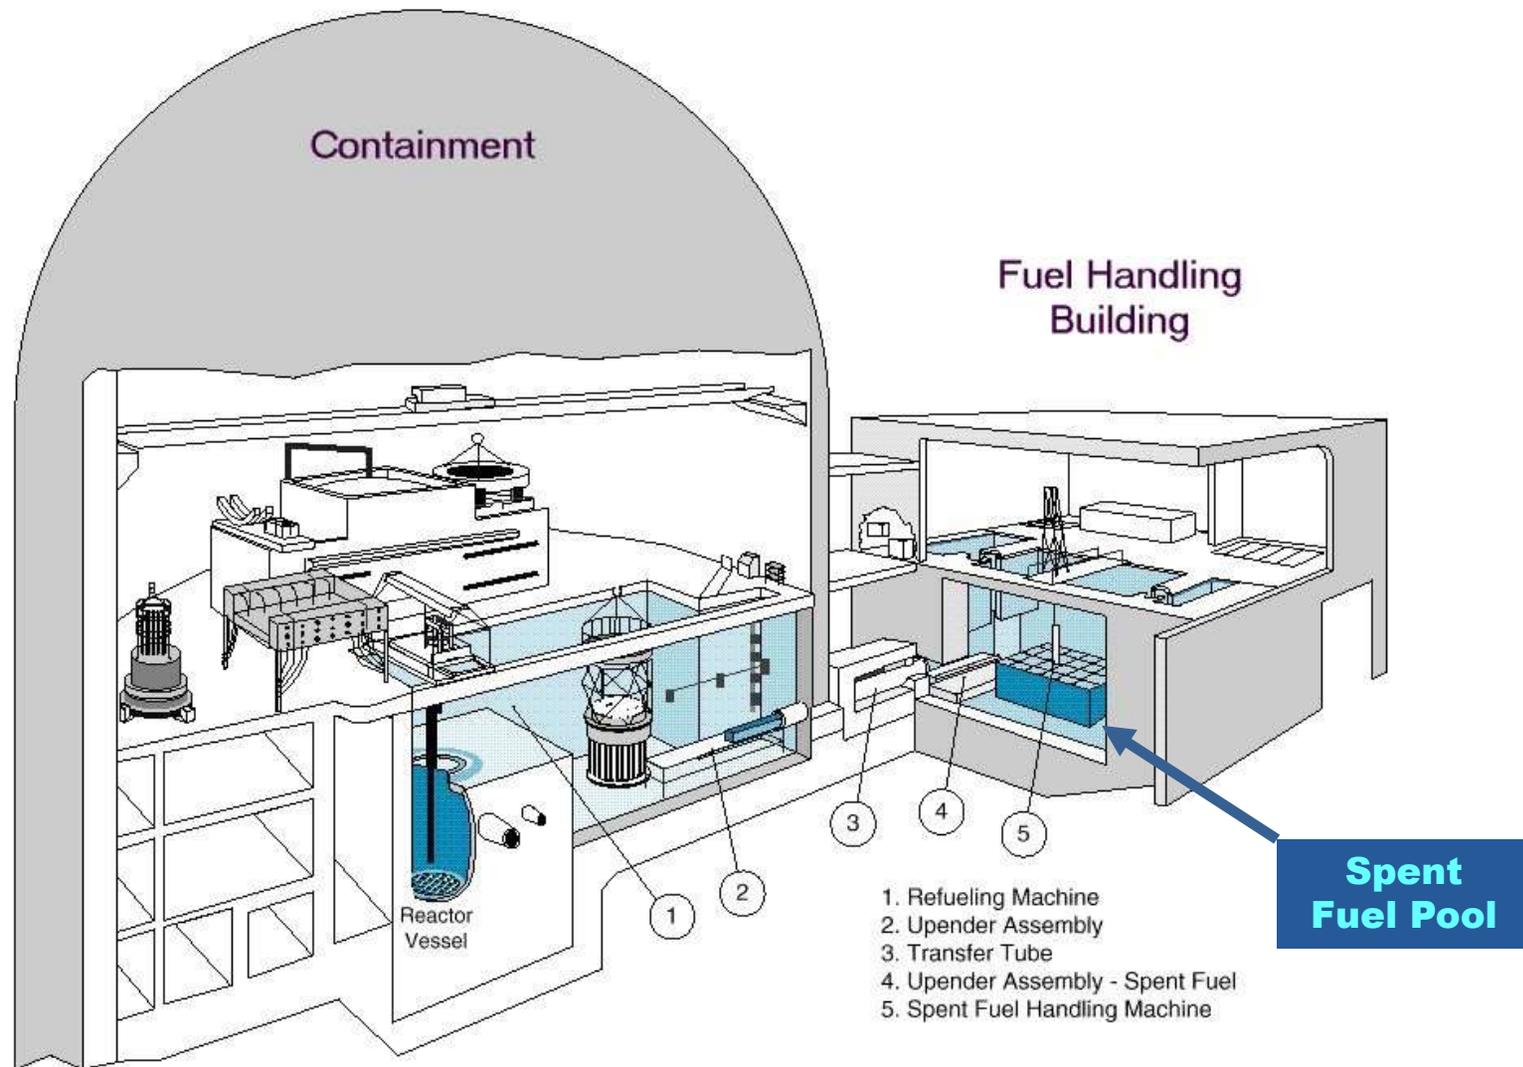
**Irradiated fuel was transferred from the reactor vessel (left) inside Containment through the horizontal transfer tube (3) to the Fuel Handling Building where it was placed in storage racks within the Spent Fuel Pool.**

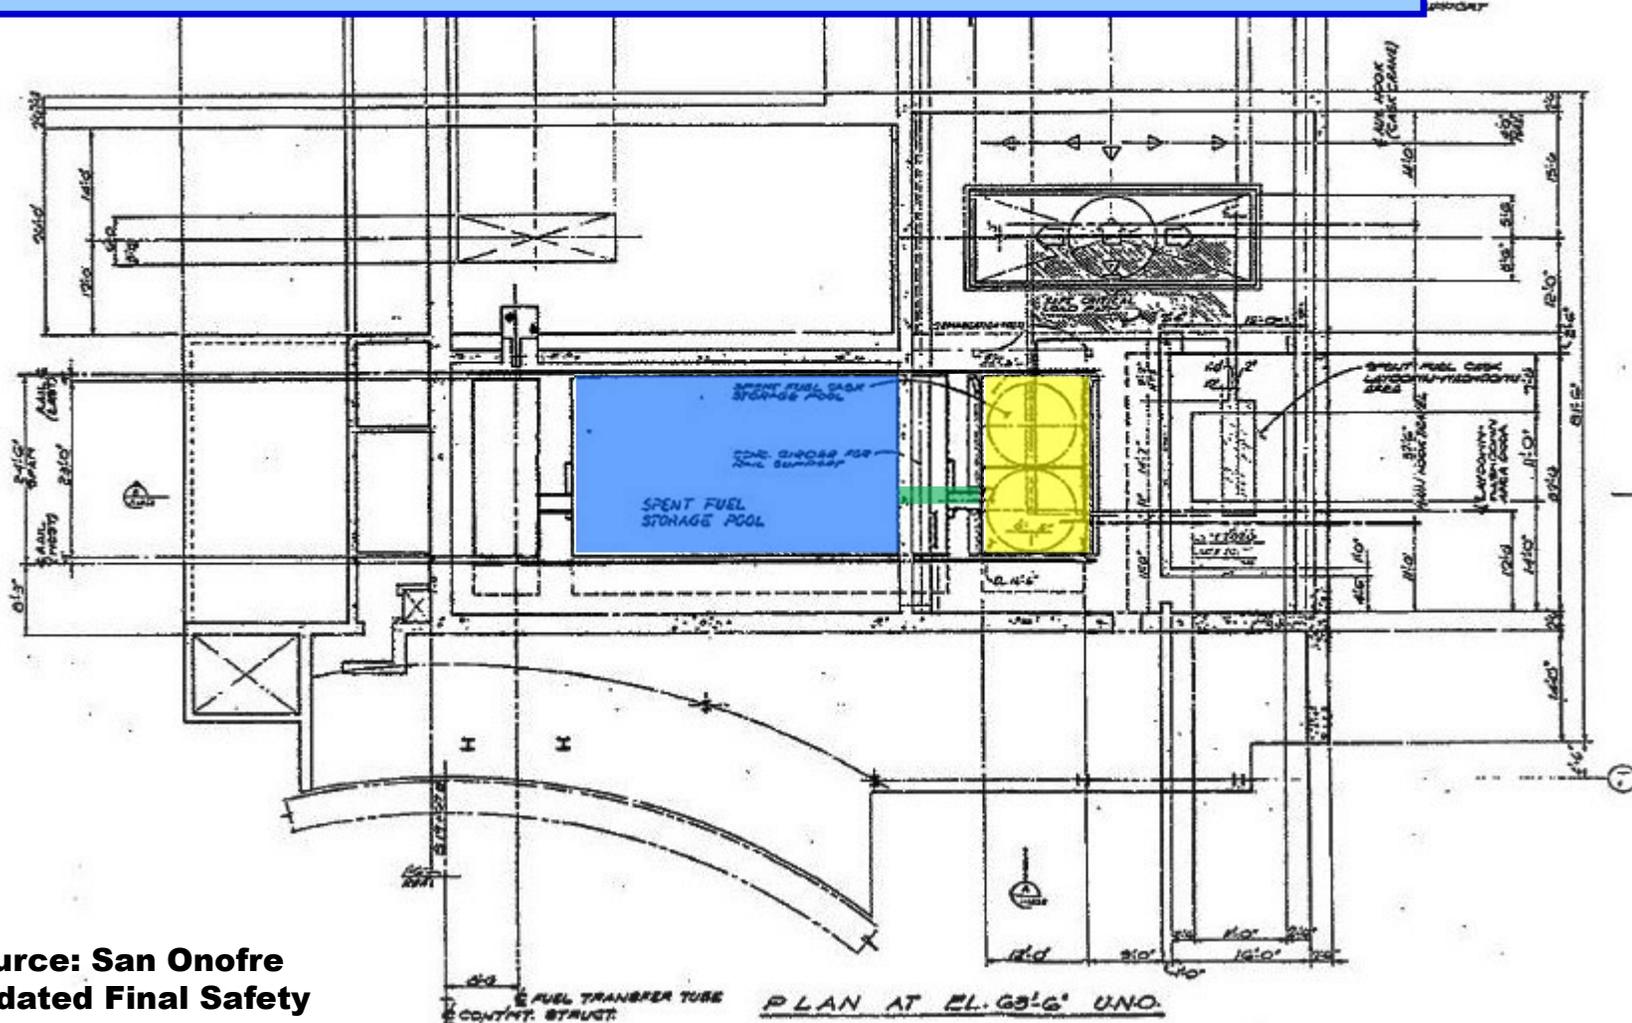
Looking down at the Fuel Handling Building: Irradiated fuel is moved through another channel (green) into the Spent Fuel Cask Storage Pool (yellow) where it is placed within a Multi-Purpose Canister (MPC). The two circles within the Spent Fuel Cask Storage Pool represent two different positions for the MPCs within the Spent Fuel Cask Storage Pool.

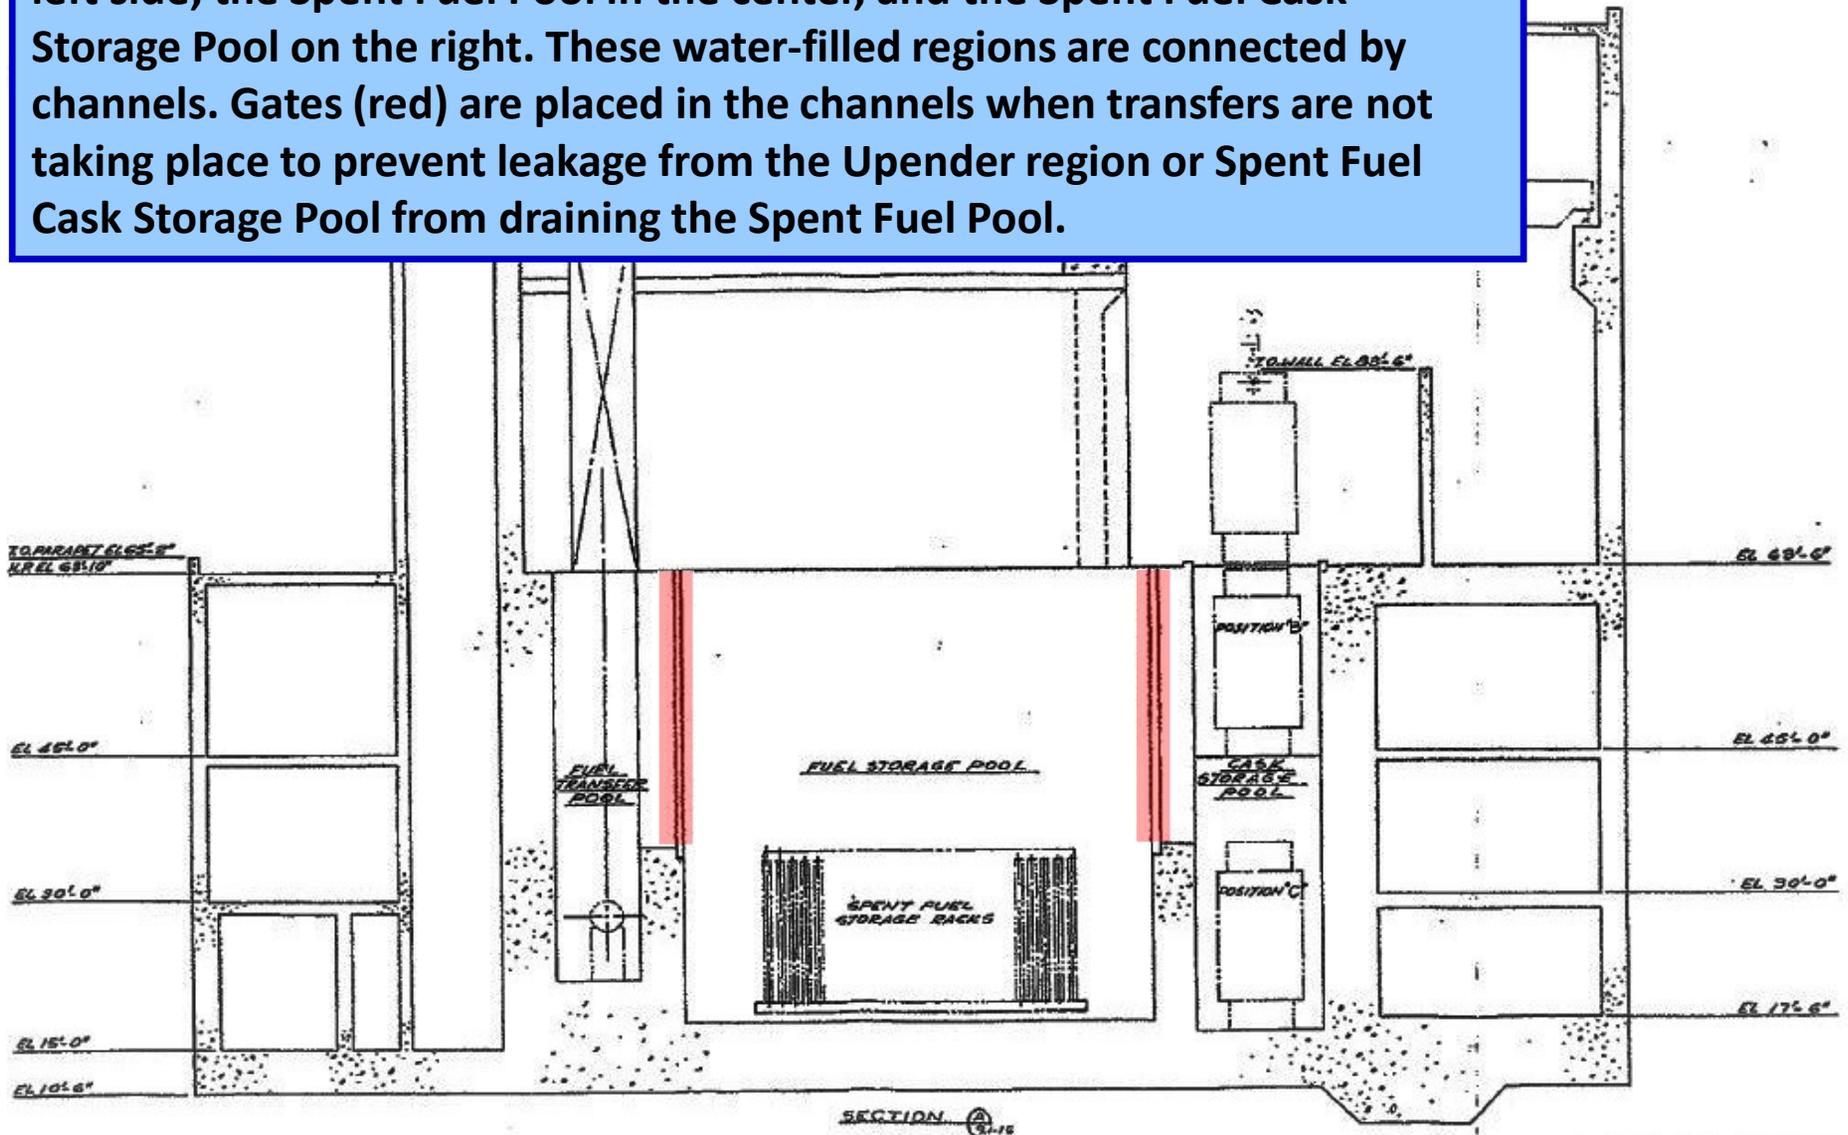
Looking at the Fuel Handling Building profile: The Upender region is on the left side, the Spent Fuel Pool in the center, and the Spent Fuel Cask Storage Pool on the right. These water-filled regions are connected by channels. Gates (red) are placed in the channels when transfers are not taking place to prevent leakage from the Upender region or Spent Fuel Cask Storage Pool from draining the Spent Fuel Pool.

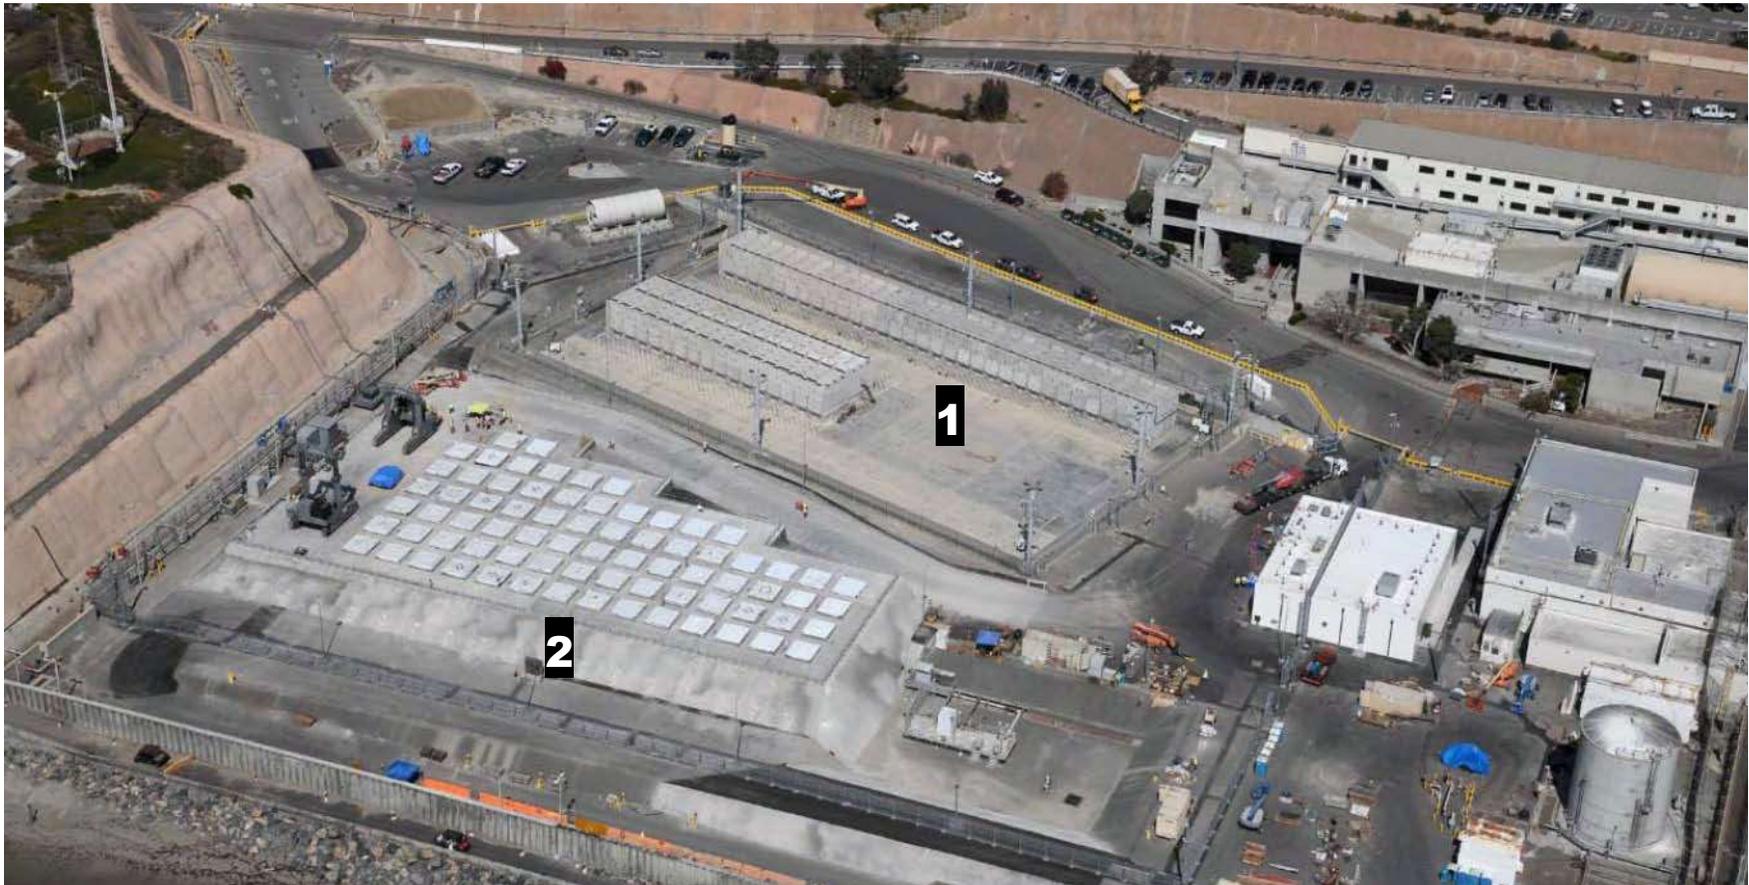
**The storage pad, or Independent Spent Fuel Storage Installation, is located north of the plant. The spent fuel for Unit 1 is housed in horizontal vaults (1). The MPC containing spent fuel for Units 2 and 3 are being placed in underground vaults (2) (each white circle marks an MPC storage location.)**

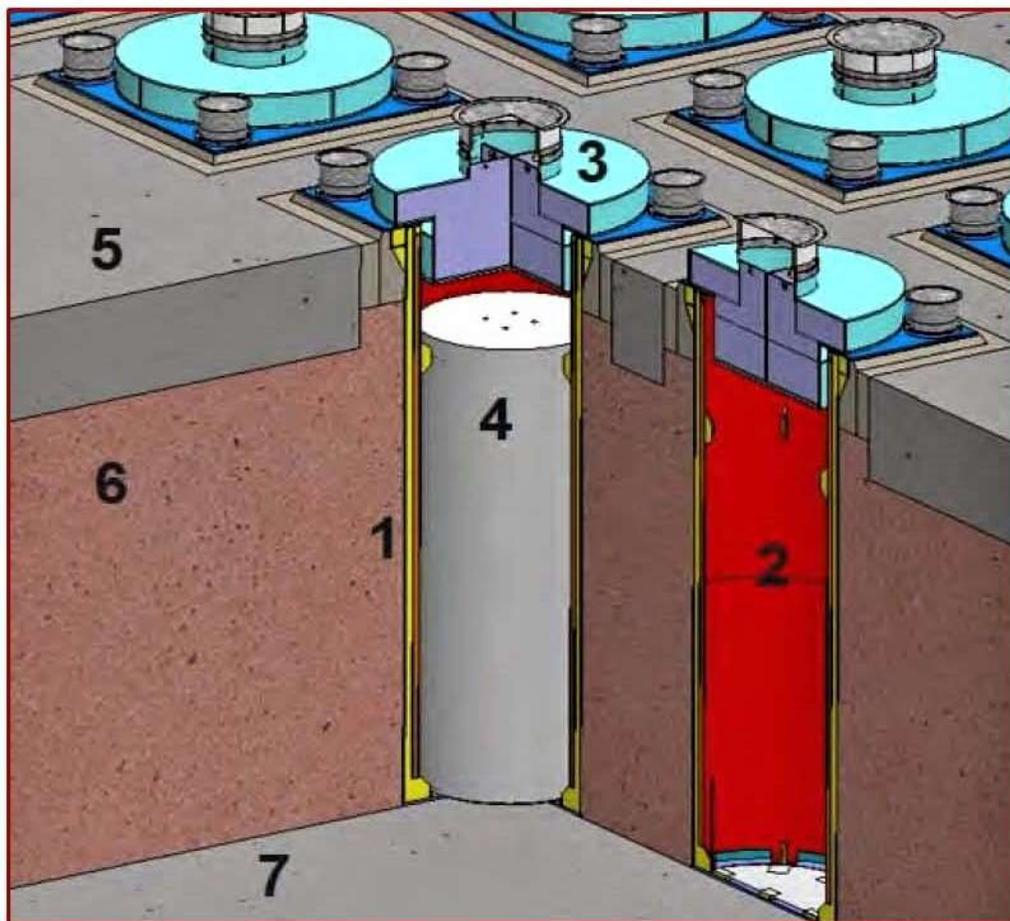
#	Component
1	Cavity Enclosure Container (CEC)
2	Divider Shell
3	Closure Lid
4	MPC-37 Multi-Purpose Canister
5	ISFSI Pad
6	Self-Hardening Engineered Subgrade (SES)
7	Support Foundation Pad (SFP)

**Cross-section view of the underground storage area: MPCs (4) are lowered into metal Cavity Enclosure Containers (1) solidly placed in the concrete block (6). The Closure Lid (3) is placed on the Cavity Enclosure Container.**

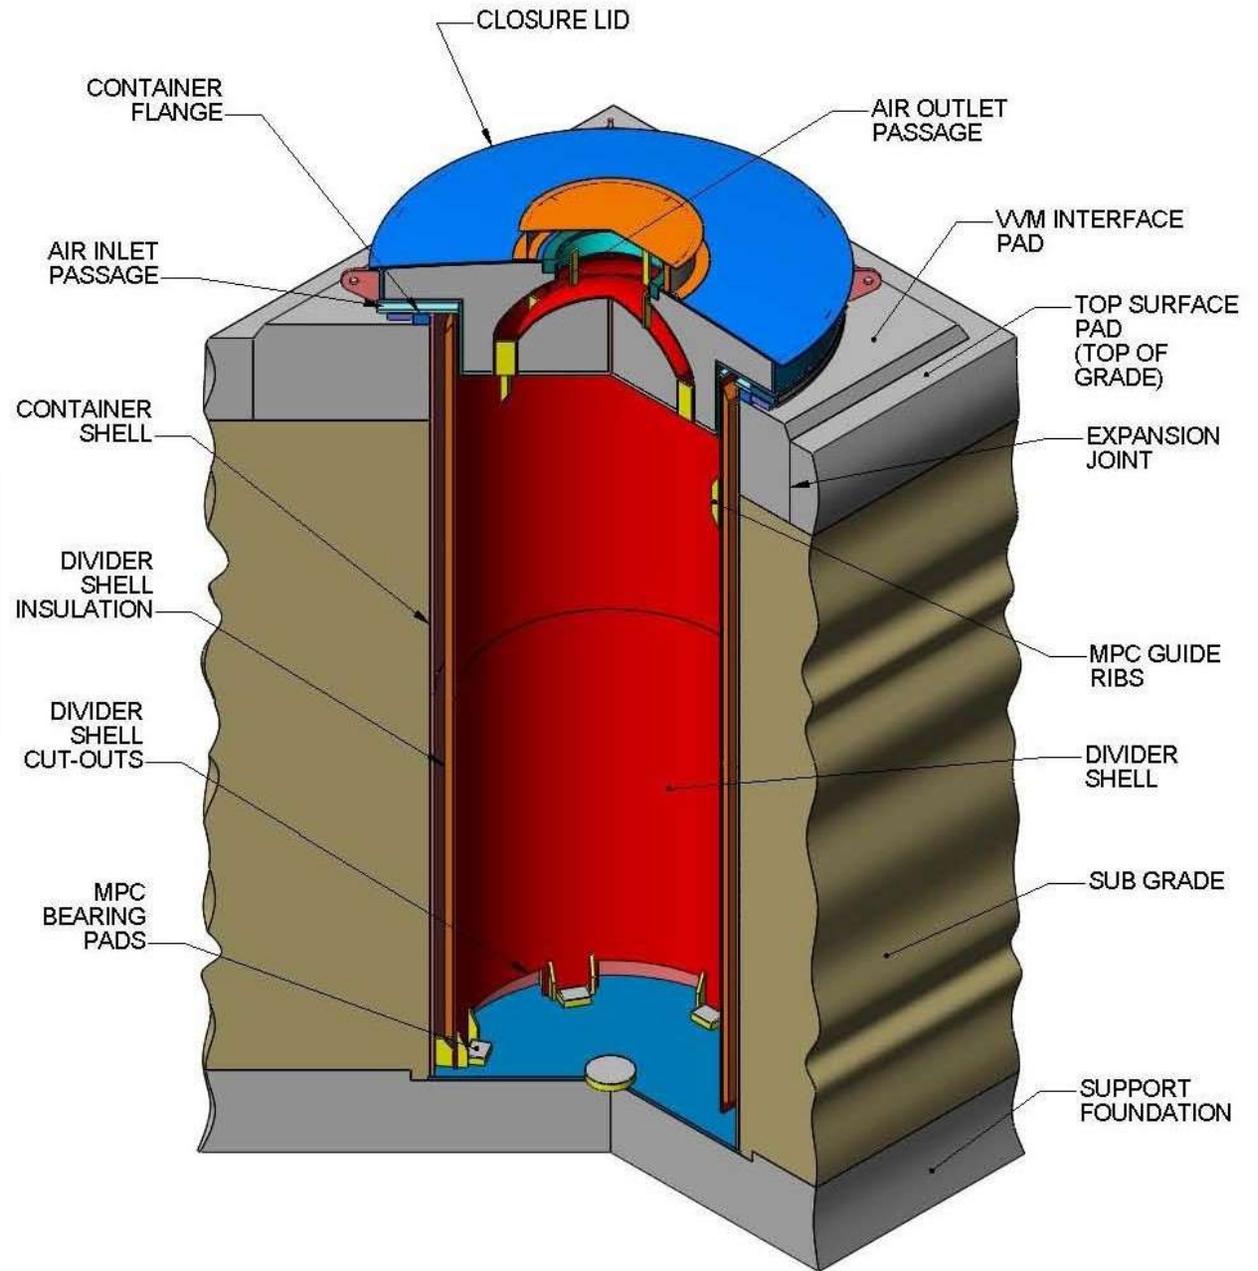
Cross-section view of a single underground storage unit before an MPC is placed in it.

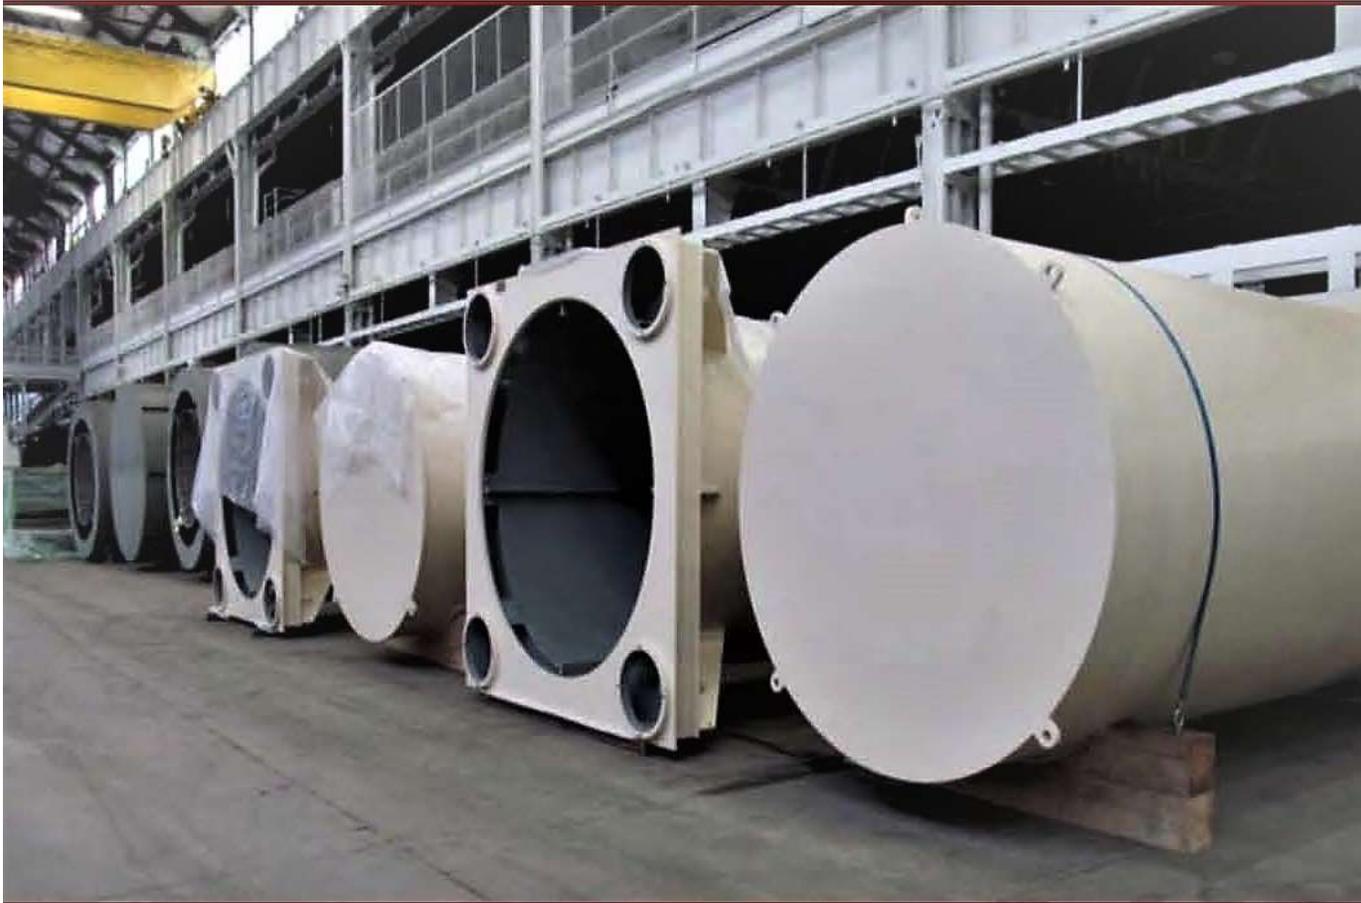
## Fabricated CECs at the HOLTEC Manufacturing Division

Row of Cavity Enclosure Containers (CECs). The CEC on the right has its bottom end facing the camera. The next CEC has its top end showing. The four openings on the corners allow cooling air to flow into the unit.

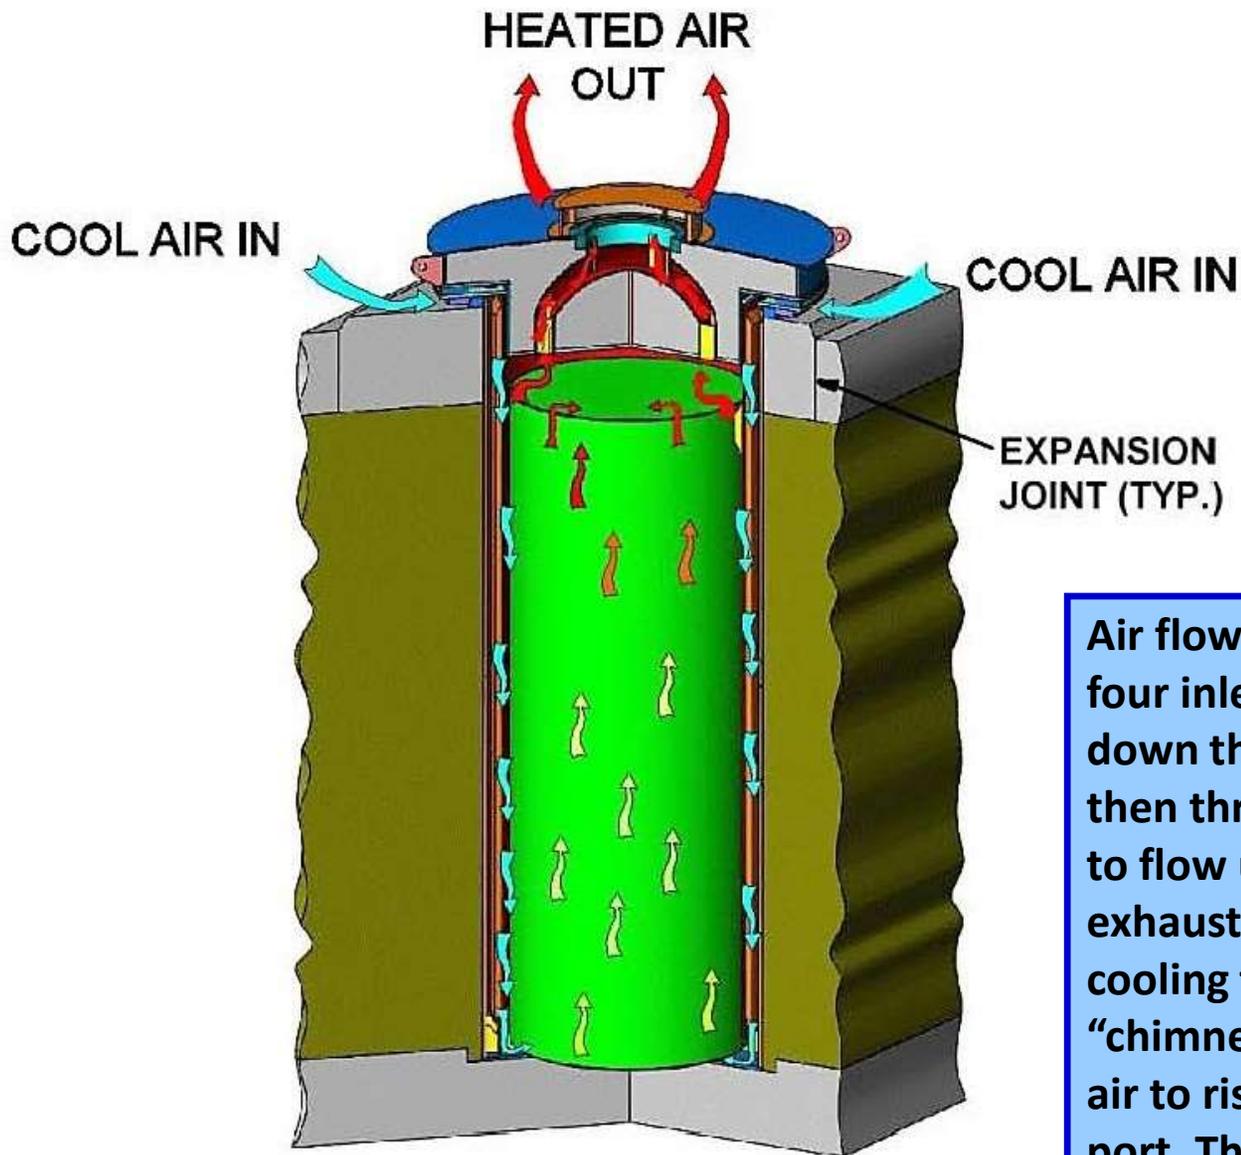
Air flows into the unit through the four inlets in the container flange, down the annulus region and then through ports at the bottom to flow upward and out the exhaust port. This is passive cooling through convection. The “chimney effect” causes warmed air to rise and leave the exhaust port. The leaving warm air pulls cool air in through the four inlets.

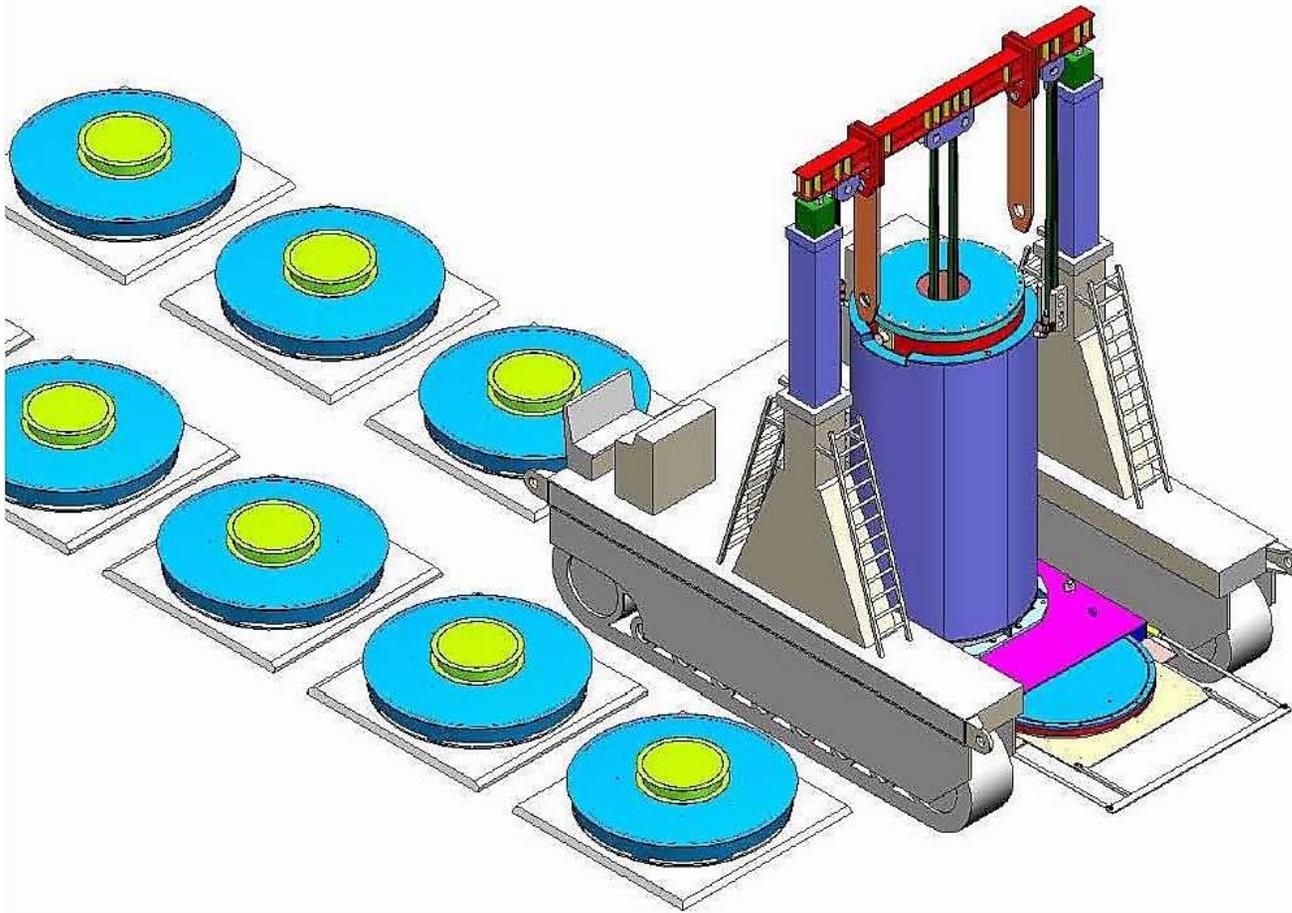
**A loaded MPC weighs about 45 tons. A special transport rig is used to move the loaded MPC from the Fuel Handling Building to the Independent Spent Fuel Storage Installation. This rig is used to lower the MPC into the Cavity Enclosure Container.**

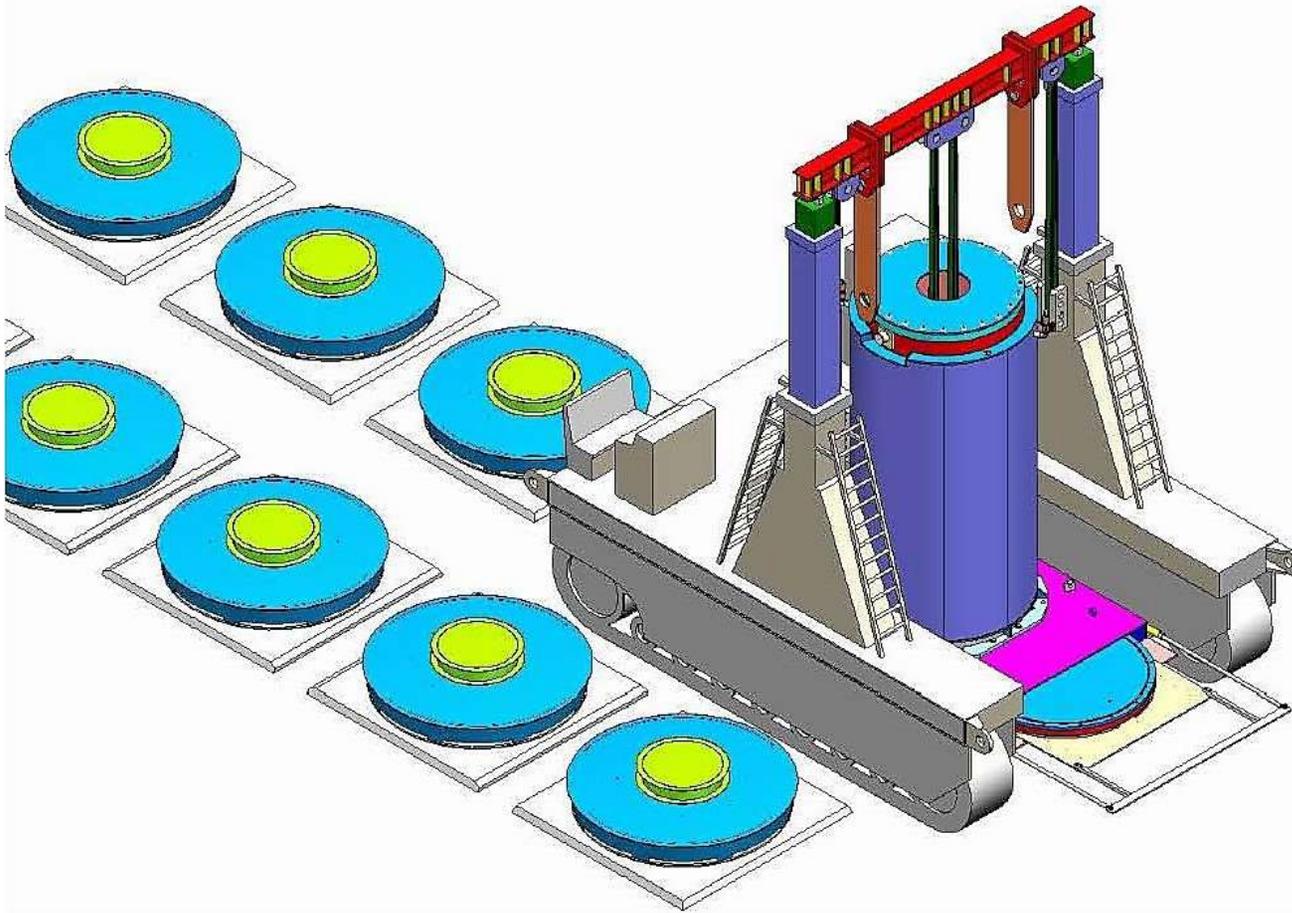
**The MPC contains highly radioactive spent fuel. The Cavity Enclosure Containers and concrete vaults shield workers and the environment. During transport, the MPC is within a transport sleeve that shields workers from radioactive emissions. The red top of an MPC and its blue closure lid are peeking out from the top of a purple transport sleeve.**

The special transport rig is “invisible” in this graphic to show an MPC being lowered into a Cavity Enclosure Container (CEC).

At this point, the MPC is more than halfway out of the transport sleeve into the CEC.

It takes about a minute for an MPC to be fully lowered into a CEC.

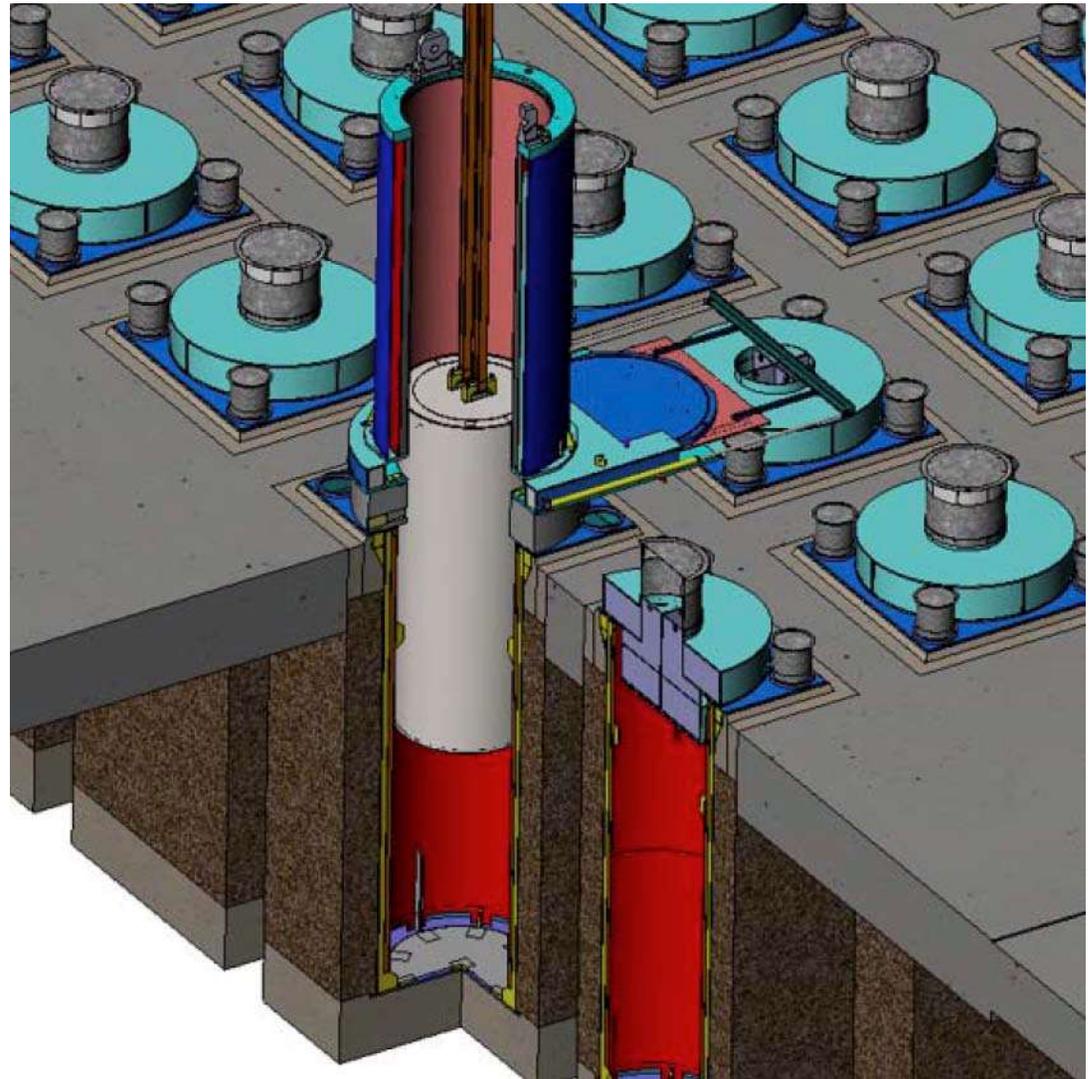
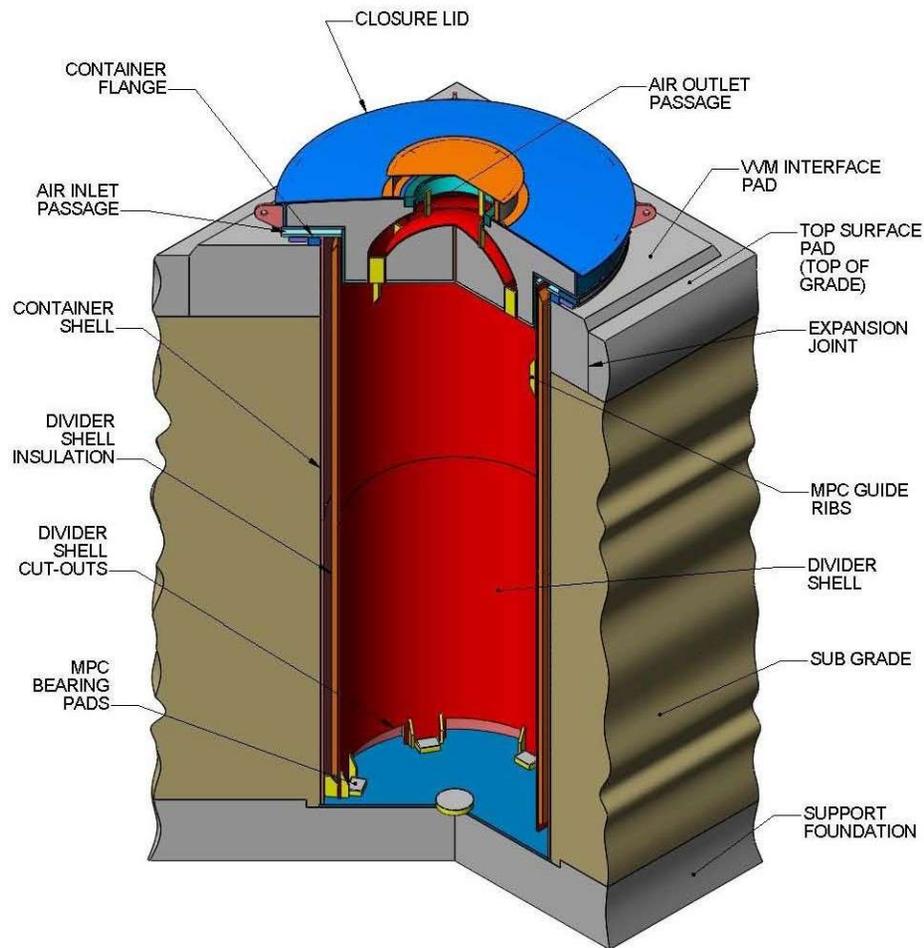
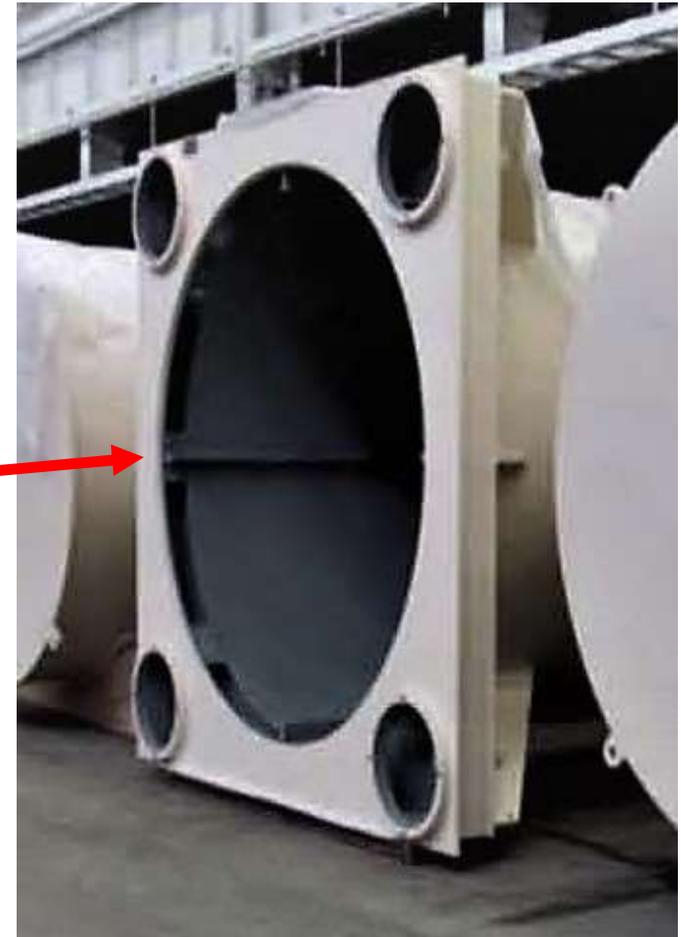
The MPC fits into the CEC like a hand in glove, except in this case the glove is rigidly made from steel. Guide ribs help align the MPC over the CEC and guide its lowering into place.

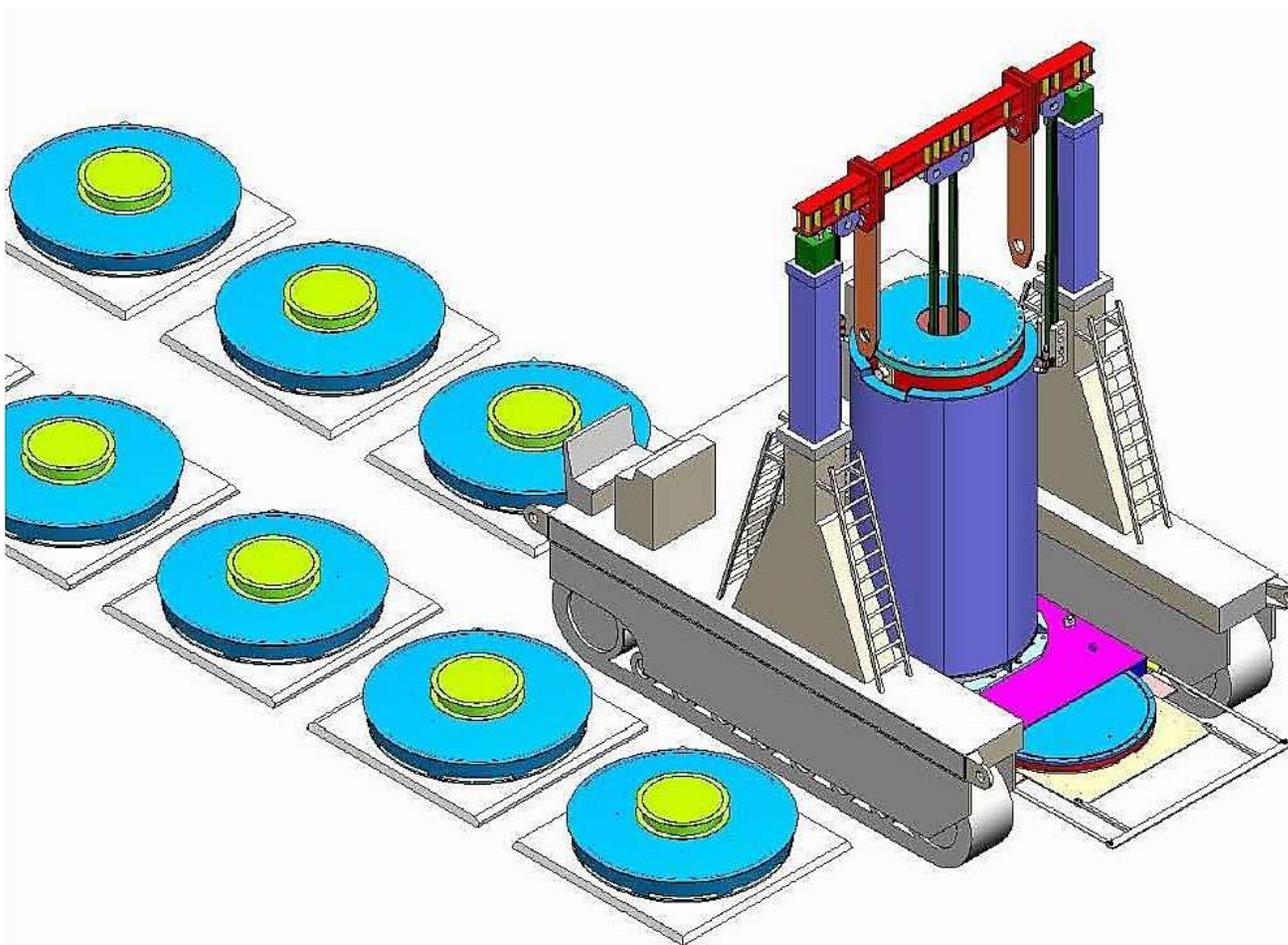
**On August 3, 2018, an MPC was not properly aligned for placement into the CEC. As workers manipulated controls on the special transport rig to lower the MPC, the rigging lowered. But the MPC got stuck and stopped moving. During the Community Engagement Panel meeting on August 9, 2018, a worker stated that the rigging was lowered another 18 feet before the MPC's non-movement was noticed.**

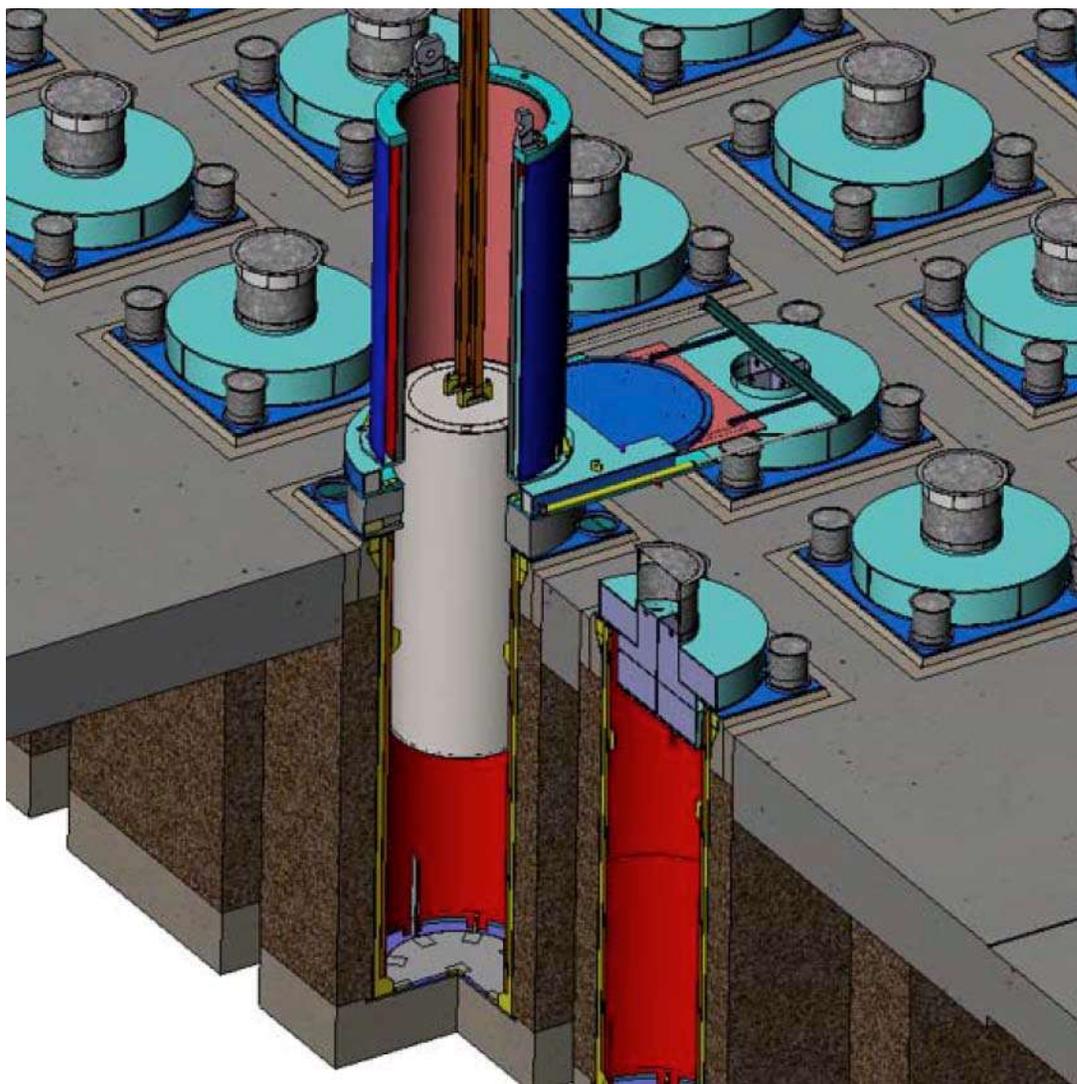
The bottom end of the MPC got caught on an edge with the CEC instead of sliding smoothly into it. Consequently, the rigging kept lowering but the stuck MPC did not.

**Not exactly a case of square peg in a round hole, but a case of a round peg not properly inserting into a round hole of only slightly larger diameter.**

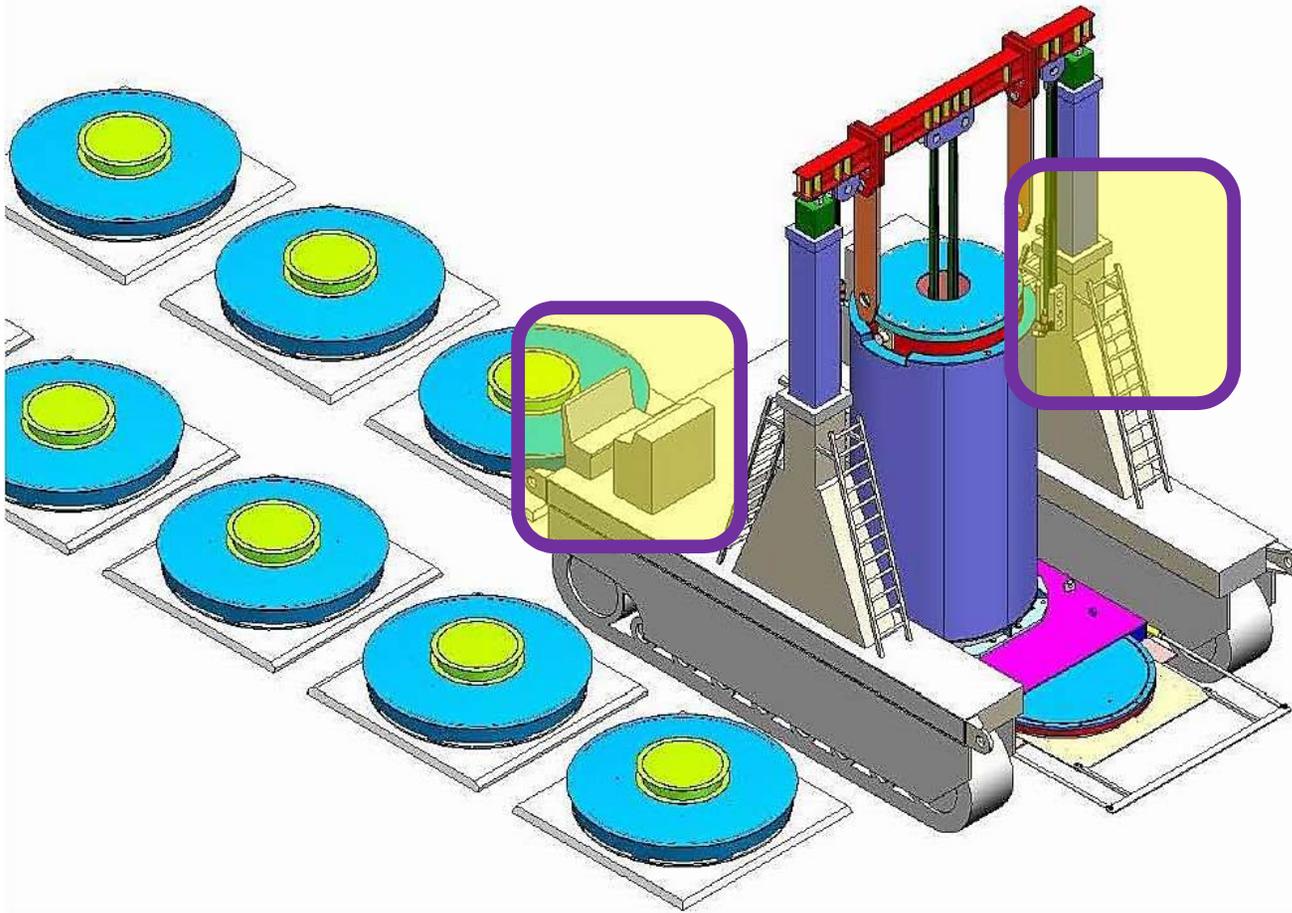
**Two workers were assigned to monitor the MPC being lowered into the CEC. The worker at the controls (left) could toggle between indications of the MPC movement and the rigging alignment. Another worker was tasked with visually monitoring the top of the MPC as it was lowered into the CEC.**
