# **Dry Storage Issue at San Onofre**

**David Lochbaum**

**August 2018**

**During the August 9, 2018, Community Engagement Panel meeting, a worker revealed that a spent fuel canister could have been dropped on August 3<sup>rd</sup> due to poor performance by two workers.**

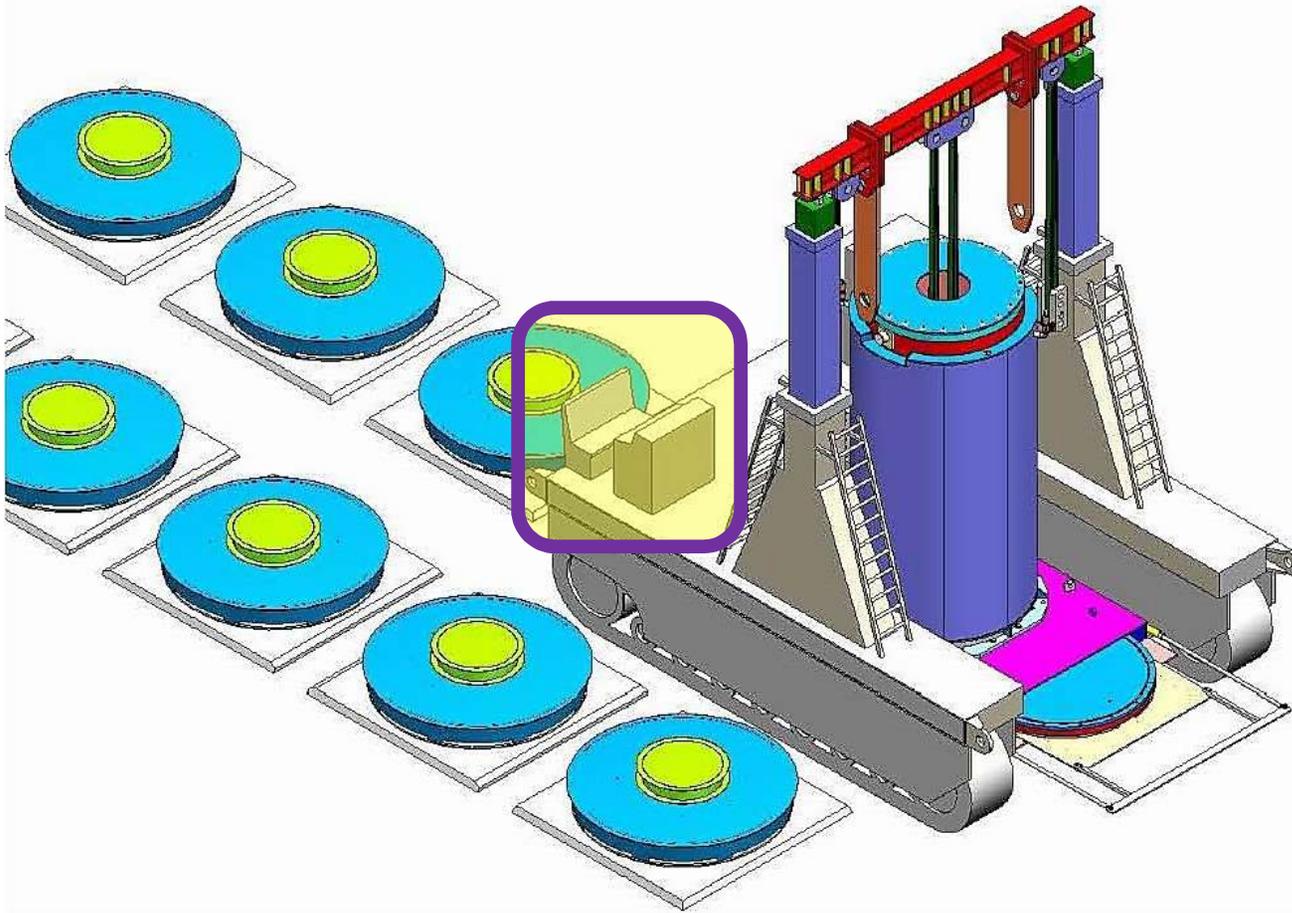
Once the MPC began moving, the “eyeball” worker retreated to a safer distance to reduce radiation dose. The worker at the controls fixated on ensuring both sides of the rigging remained level. After about 30 seconds, the worker saw that the MPC was not moving, but mistakenly thought the indication meant it had reached the bottom of the CEC. It had not.

**Workers juggling competing concerns (i.e., dose reduction and rigging performance) let the ball drop by failing to notice that the MPC was not dropping.**

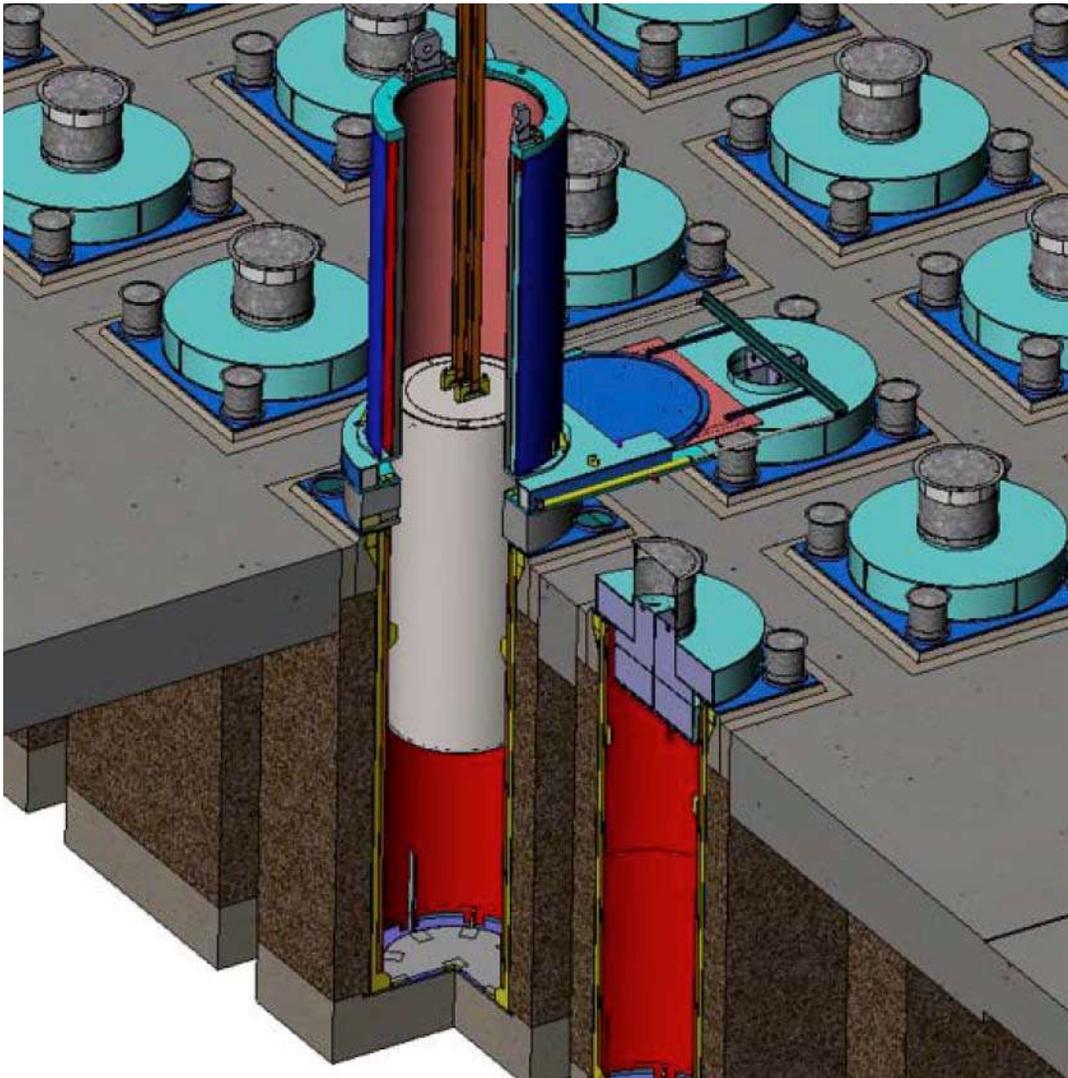
**A Radiation Protection technician surveyed the Cavity Enclosure Container and detected radiation levels higher than expected for a properly loaded MPC.**

**A worker looked into the transport sleeve and observed the top of the MPC at a higher level than desired.**

**About 20 minutes after being noticed in the wrong position, the MPC was unstuck and lowered fully into the CEC.**

**By procedure, Radiation Protection surveyed the area after the MPC was thought to have been placed in the CEC. Unexpectedly high radiation readings lead to the stuck MPC being noticed.**

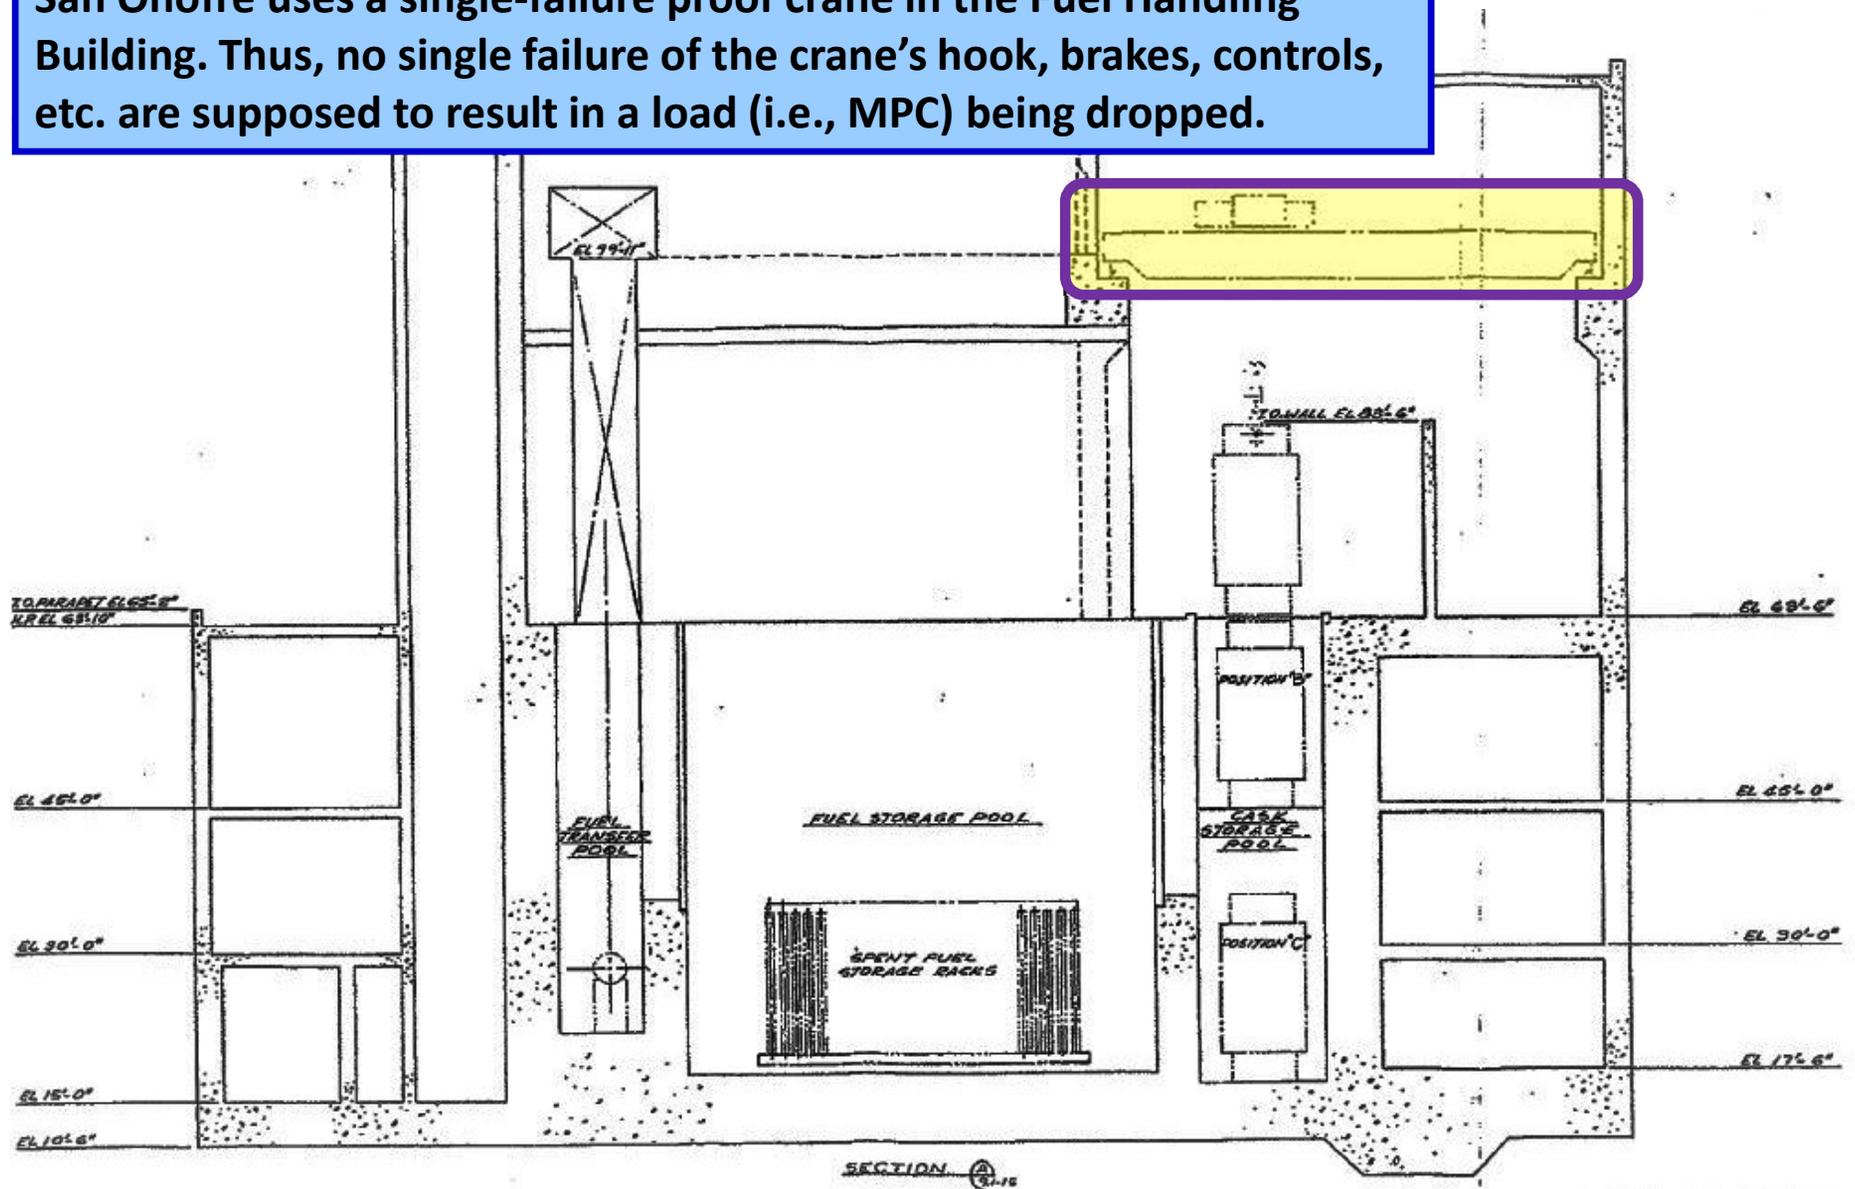
San Onofre uses a single-failure proof crane in the Fuel Handling Building. Thus, no single failure of the crane's hook, brakes, controls, etc. are supposed to result in a load (i.e., MPC) being dropped.

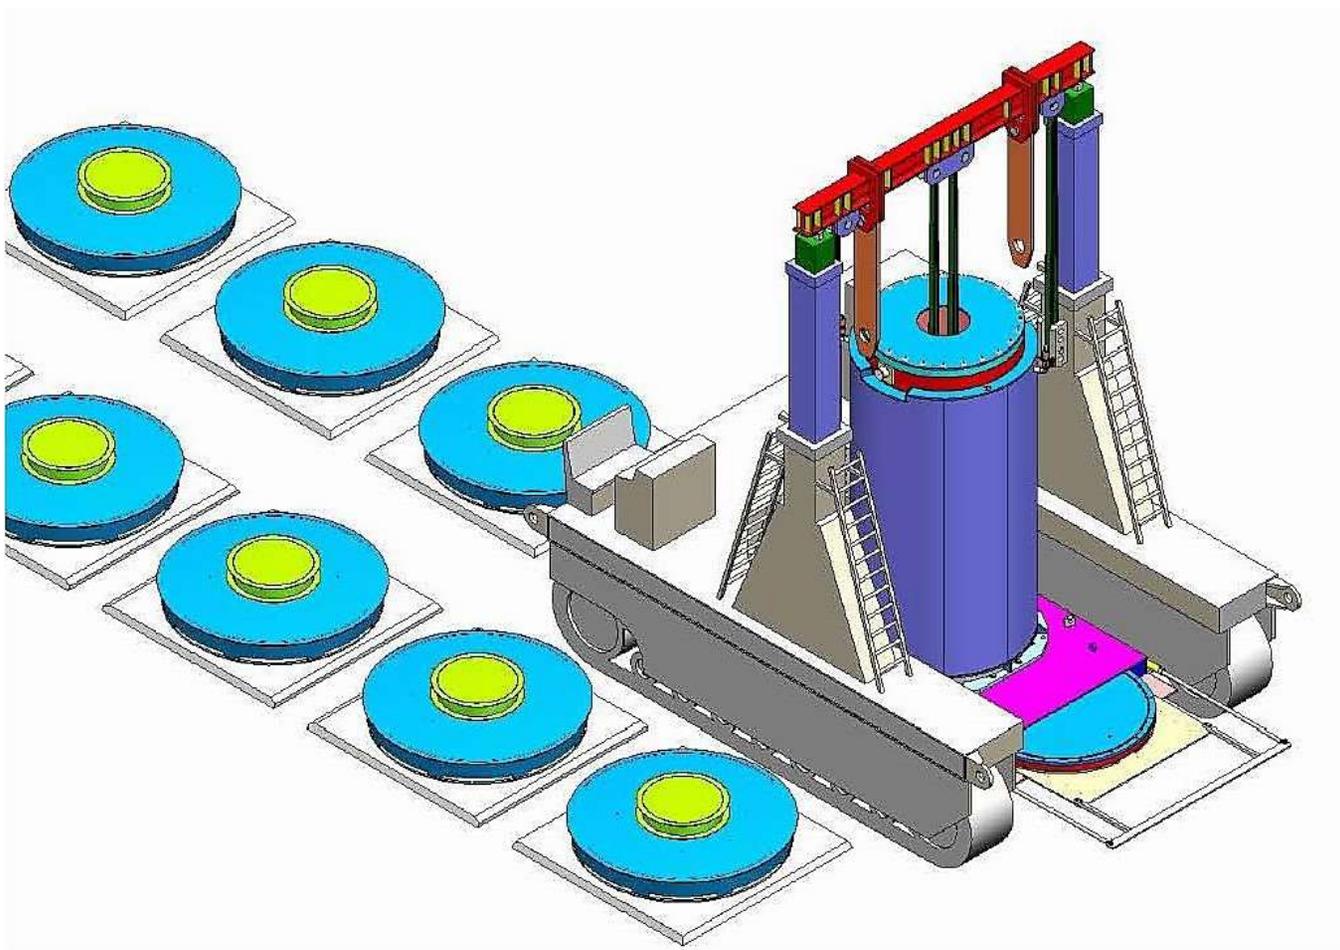
**The special transport rig can only lift a MPC a few feet off the ground and is also single-failure proof. The farthest that a rig could conceivably drop the MPC would be less than 30 feet into a Cavity Enclosure Container.**

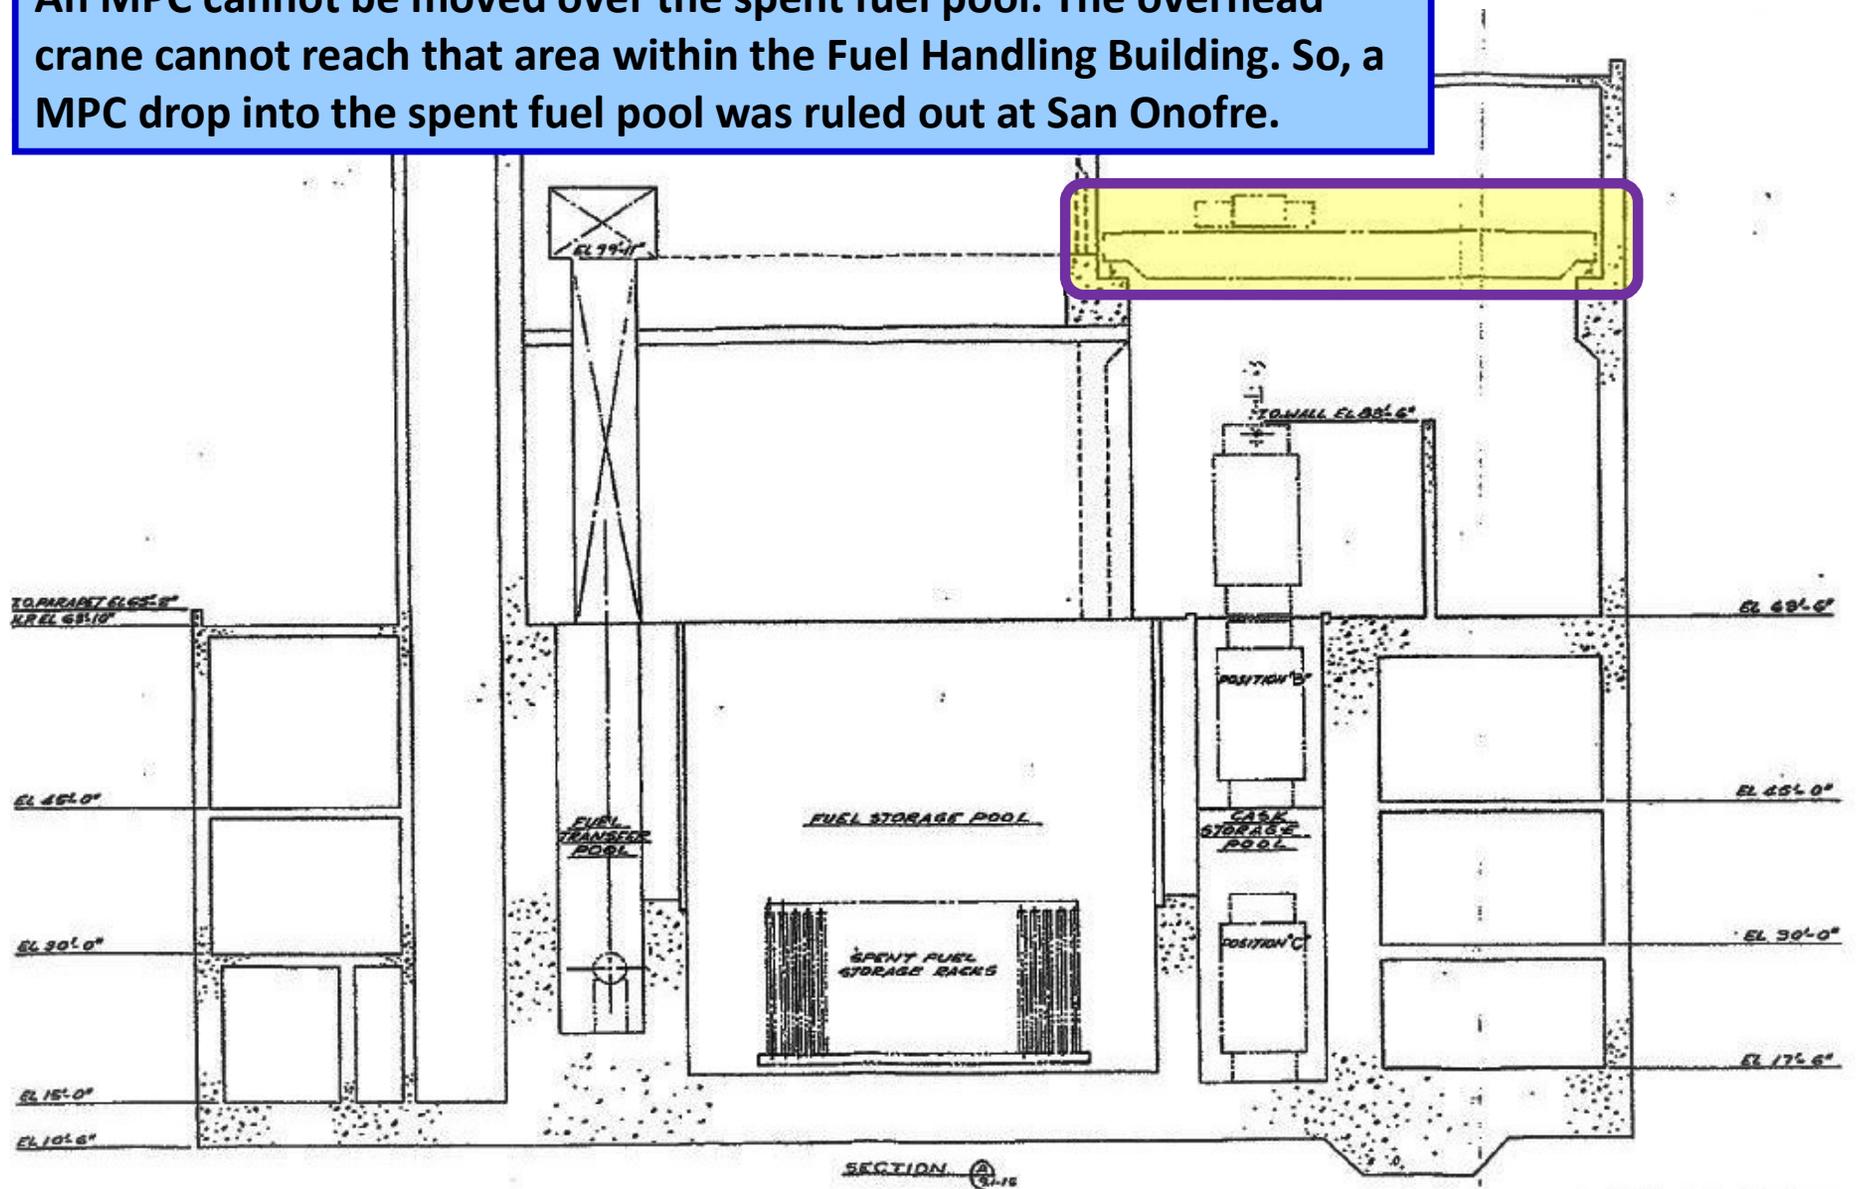
An MPC cannot be moved over the spent fuel pool. The overhead crane cannot reach that area within the Fuel Handling Building. So, a MPC drop into the spent fuel pool was ruled out at San Onofre.

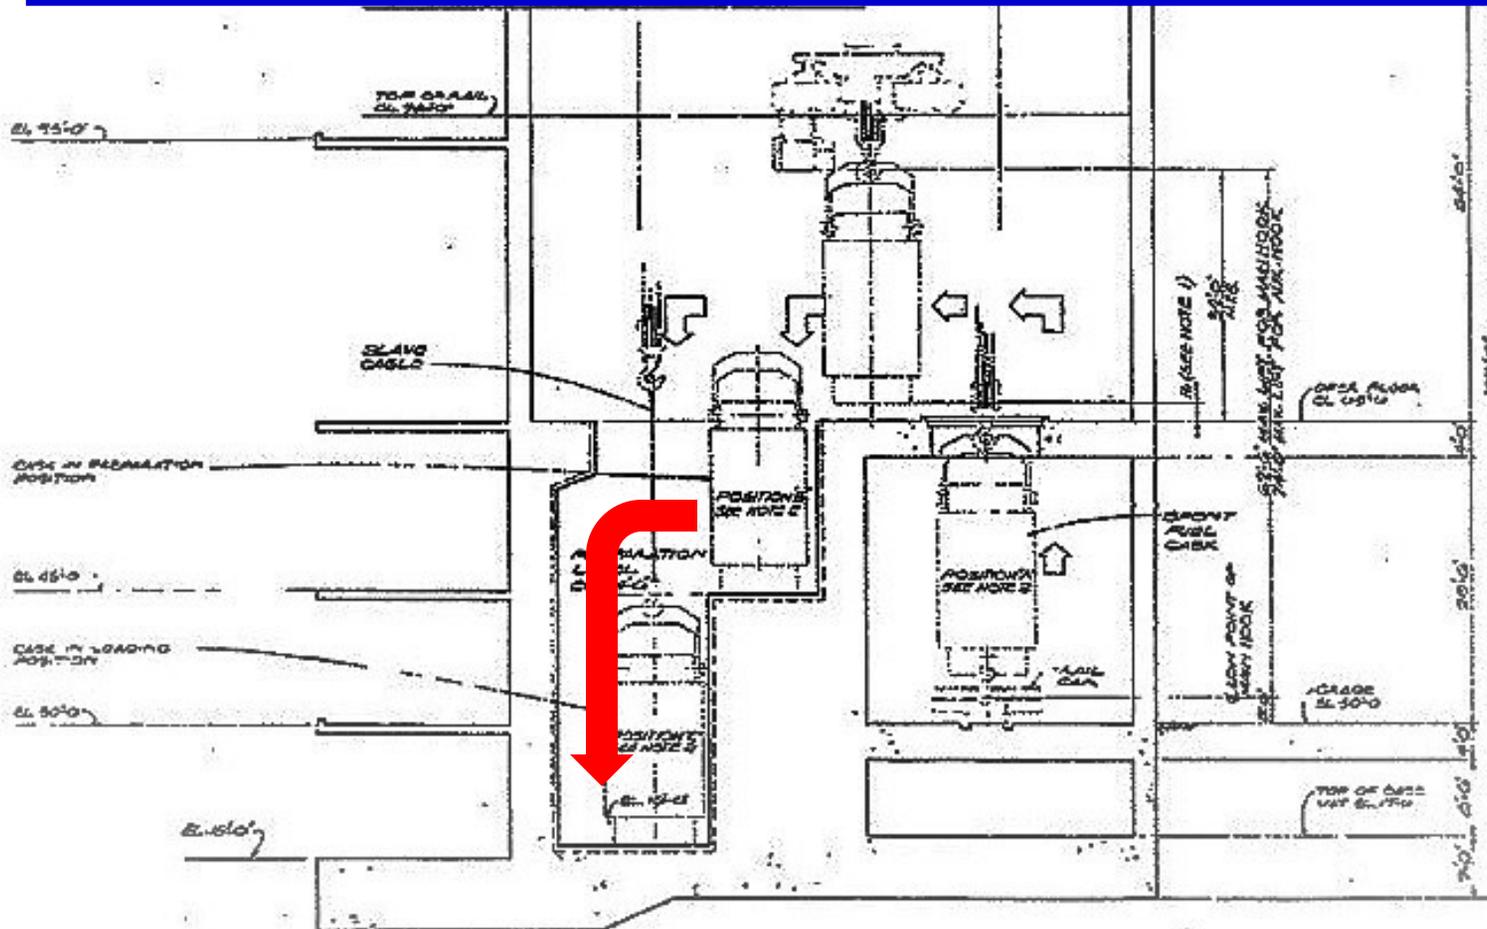
An earthquake could shake an MPC off the “step” in the Spent Fuel Cask Storage Pool. An analysis of a drop from the “step” concluded that irradiated fuel inside the MPC might be damaged, but the MPC would remain intact. No radioactivity would be released into the Fuel Handling Building.

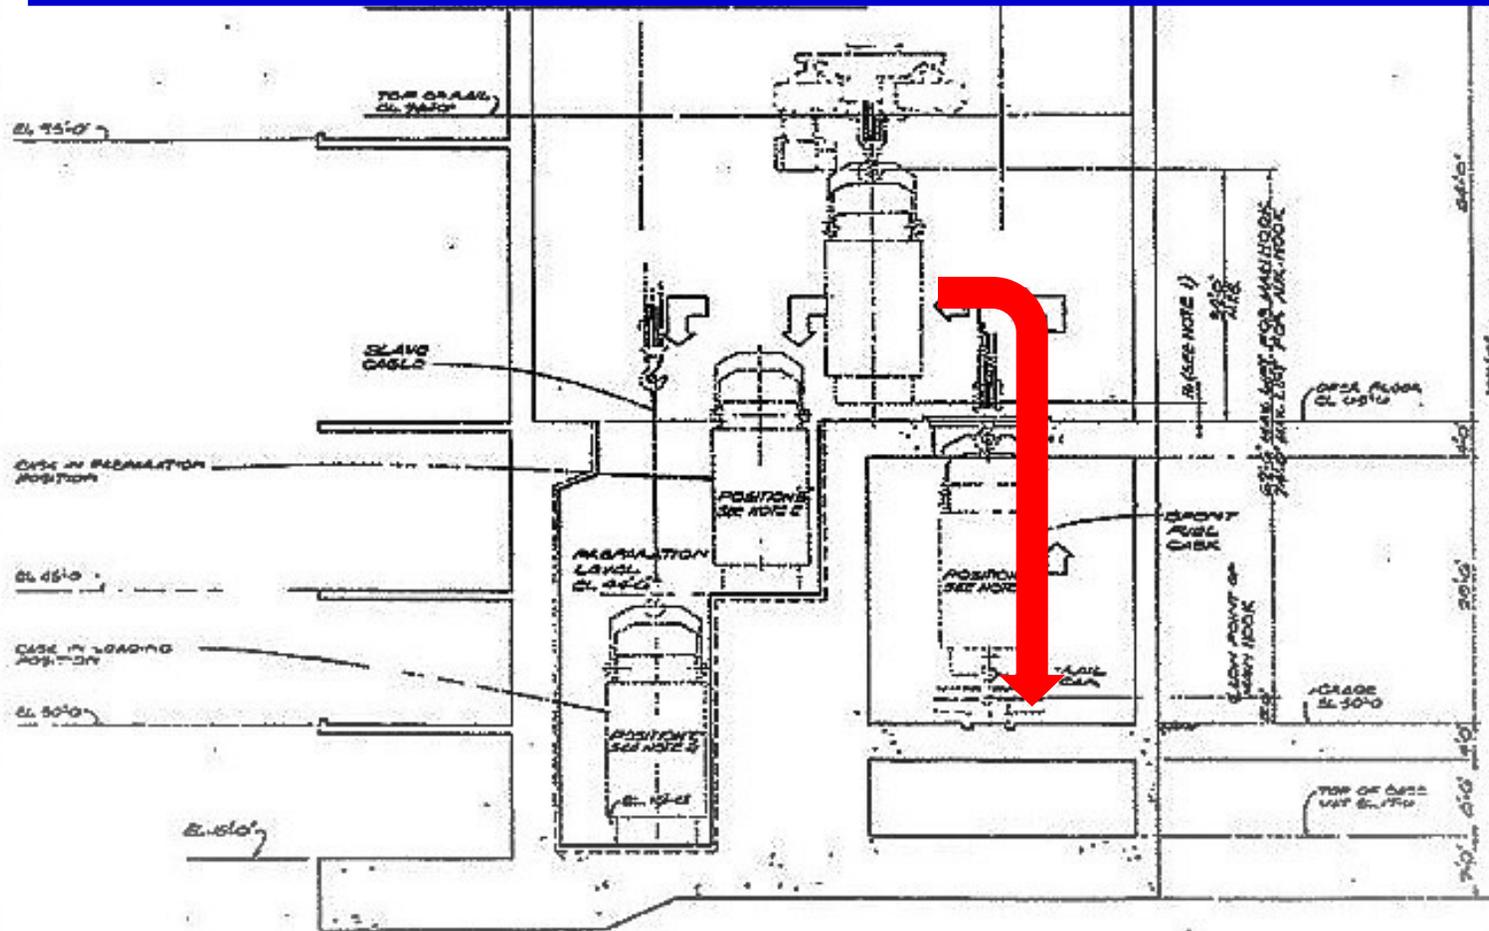
The 30-foot drop of an MPC onto a flat surface (not likely to still be flat after impact from the 45-ton MPC) was also evaluated. Again, irradiated fuel inside the MPC might be damaged, but the MPC would remain intact to prevent any release of radioactivity.
