ROOT CAUSE EVALUATION NN 201843216

Steam Generator Tube Wear San Onofre Nuclear Generating Station, Unit 2

April 2, 2012

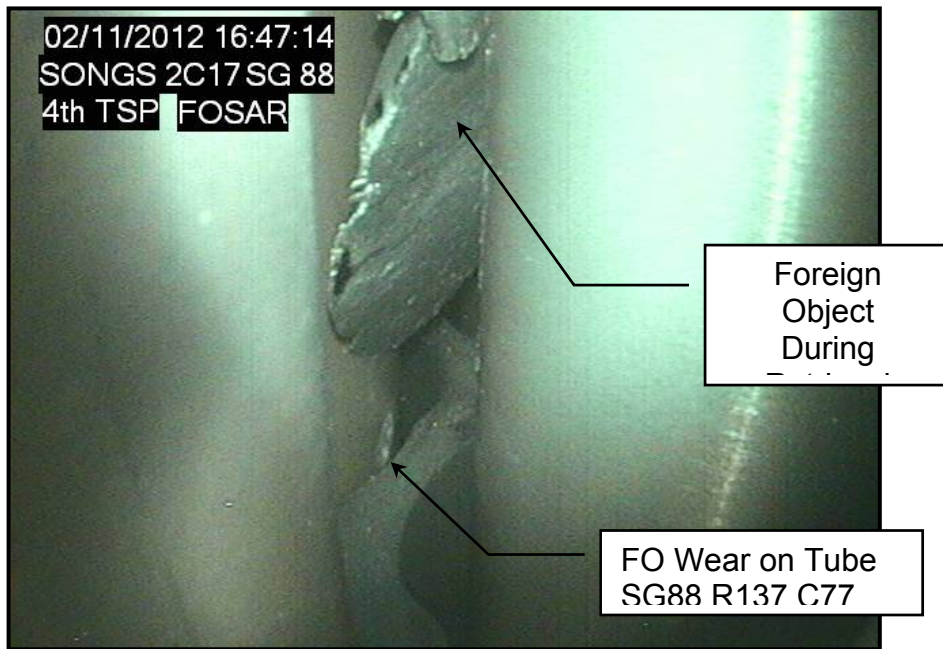
ECT showed tube wear at a location other than an AVB, TSP, or free span tube to tube. The cause of the wear was determined to be a foreign object. The object was approximately 0.75 inches in diameter by 0.1 inches thick. [REDACTED]
