BEFORE THE PUBLIC UTILITIES COMMISSION OF THE STATE OF CALIFORNIA

**ORDER INSTITUTING INVESTIGATION REGARDING
SAN ONOFRE NUCLEAR GENERATING STATION
UNITS 2 AND 3**

Attachment A: July 18, 2012 San Onofre Nuclear Generating Station – NRC
Augmented Inspection Team Report

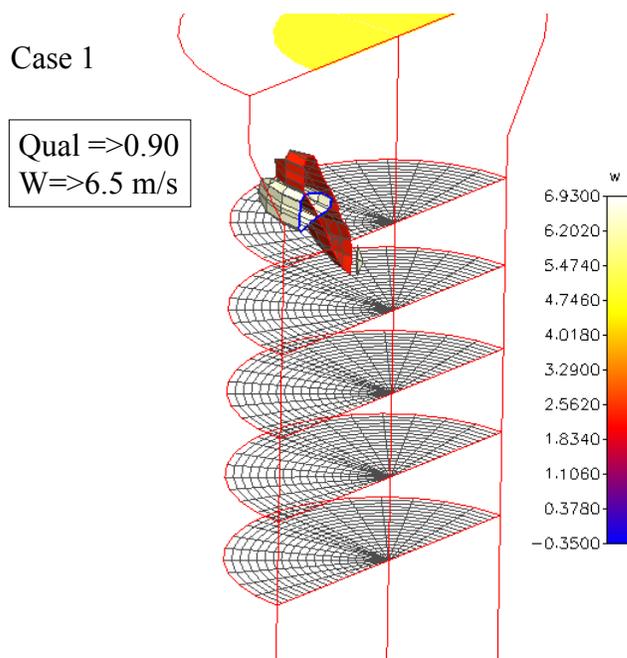
Figure 1

Figures 1 through 4 (different view angles of same results) show results, with low T_{hot} and low steam pressure and present a 3D isometric encapsulation of steam qualities (red scale) at and above 0.9 (i.e., void fraction > 0.99) and field velocities at and above 6.0 m/sec (white scale).
